Lincoln University Campus Master Plan

Workshop 4 – Steering Committee June 27, 2019

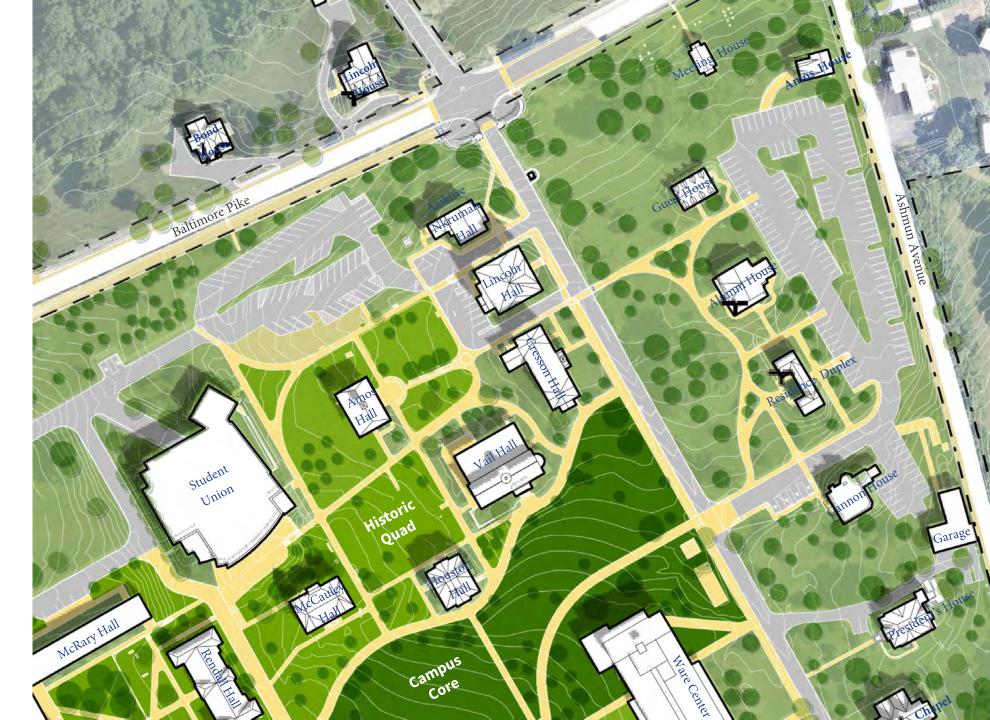
HISTORIC QUAD -EXISTING CONDITIONS

- The quad has a mix of programs of administration and residential uses.
- The quad is located at the main arrival point of the Campus.
- The quad can be improved in terms of landscape and ADA access and entry points to provide connections to the SUB and residential areas.

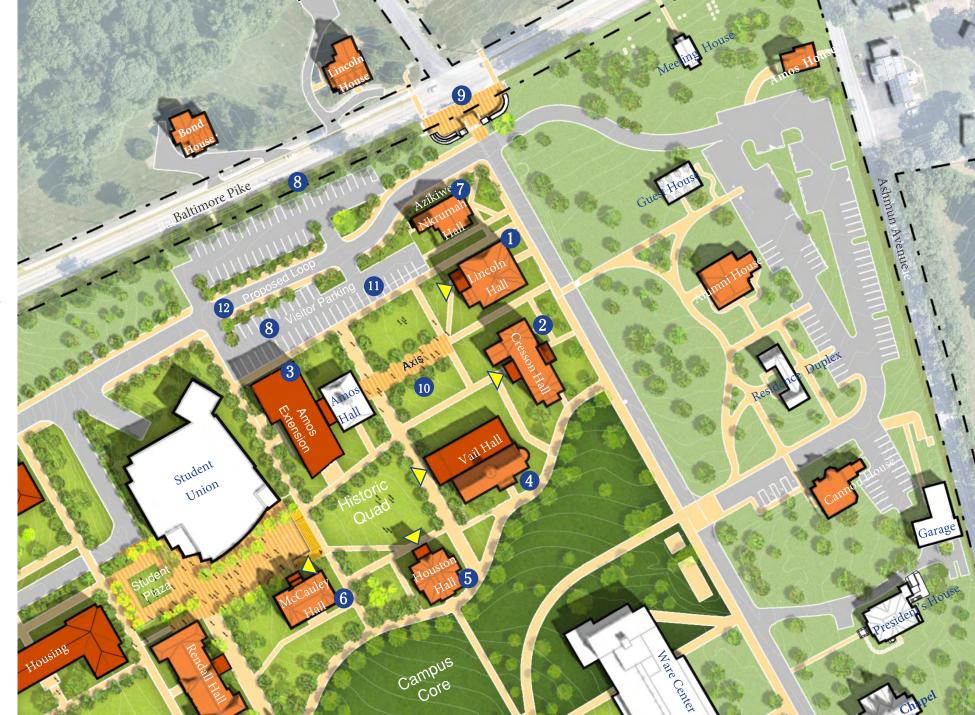
HISTORIC QUAD

- 1. Lincoln Hall Admissions, Alumni Relations, Museum
- 2. Cresson Hall Residential
- 3. Amos Art Department
- 4. Vail Hall Administrative
- 5. Houston One Stop (Fin. Aid, Bursar, Registrar)
- 6. McCauley Residential
- 7. Azikiwe Institutional Development

- 8. Edge landscape along Baltimore Turnpike
- 9. Traffic calming strategies at Memorial Arch Pedestrian entrance
- 10. Historic Quad landscape improvements- axis to Amos Hall, connections to SUB, ADA
- 11. Visitor Parking
- 12. Proposed Loop north of Historic District

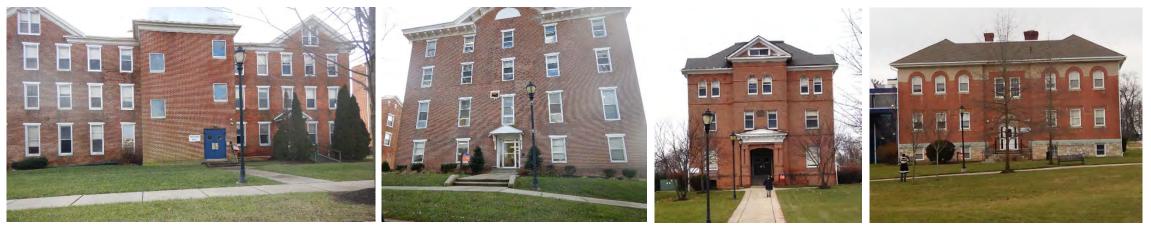
Maintain and restore the historic character of the main facades

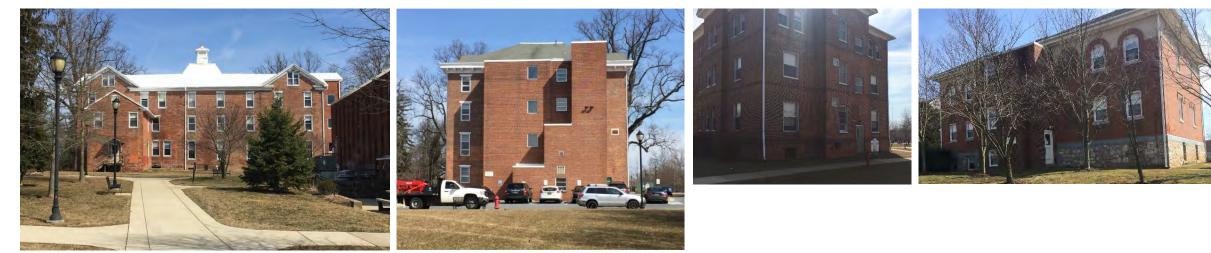
Create new entries on the back facades that respond to patterns of movement and ADA access requirements

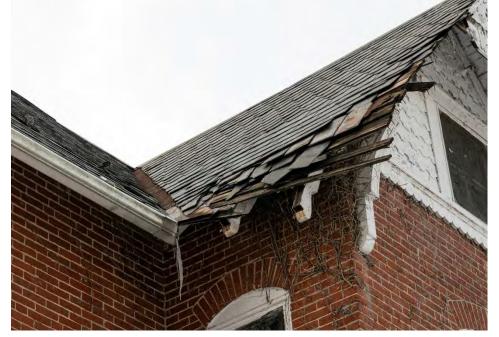
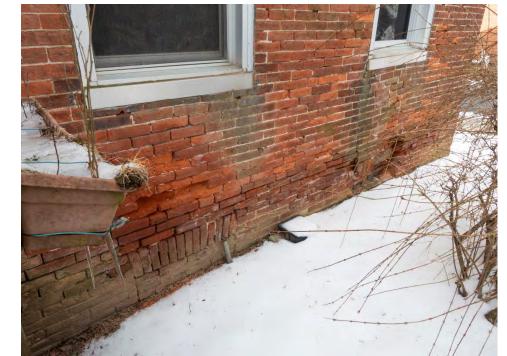
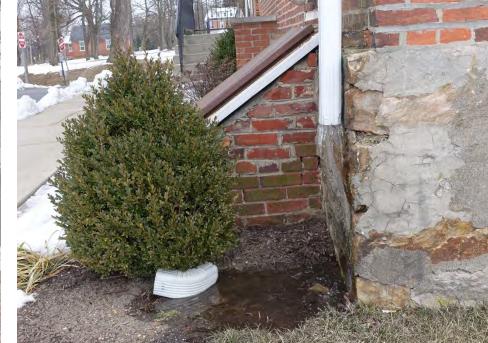
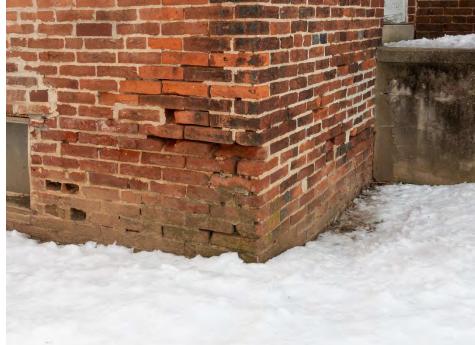
IMMEDIATE REPAIR NEEDS

- Roof Failure
- Gutters & Downspouts
- Perimeter Drainage
- Masonry Delamination/ Deterioration
- Masonry Step Cracking
- Masonry Repointing
- Exterior woodwork repair

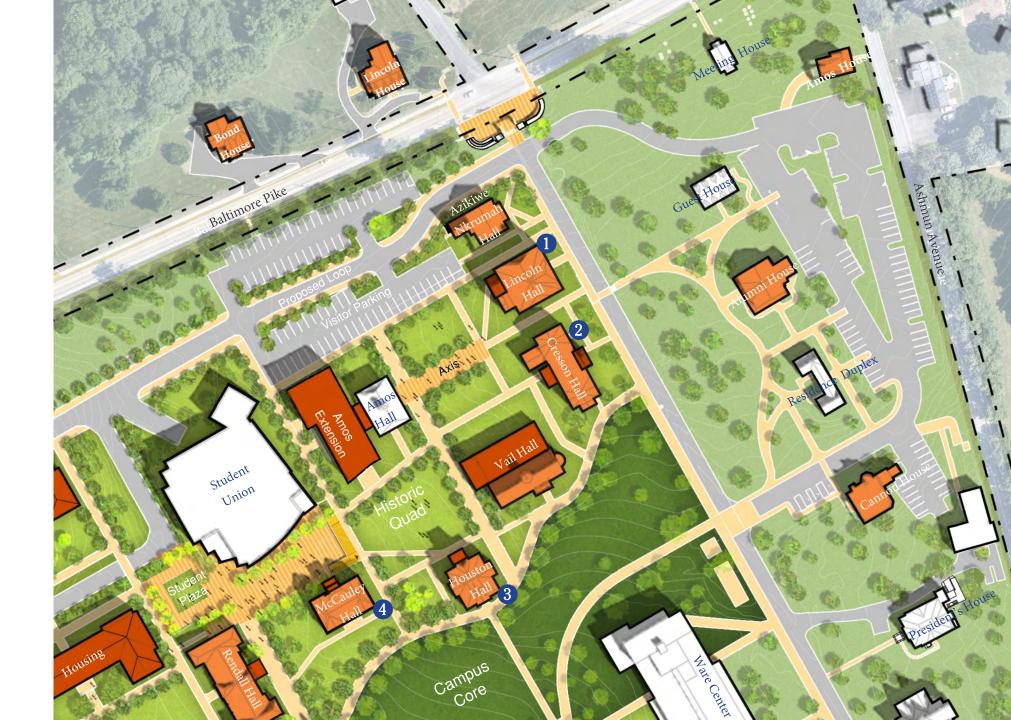
HISTORIC LARGE-SCALE BUILDINGS

- 1. Lincoln Hall (1866)
- 2. Cresson Hall (1870)
- 3. Houston Hall (1881)
- 4. McCauly Hall (1904)

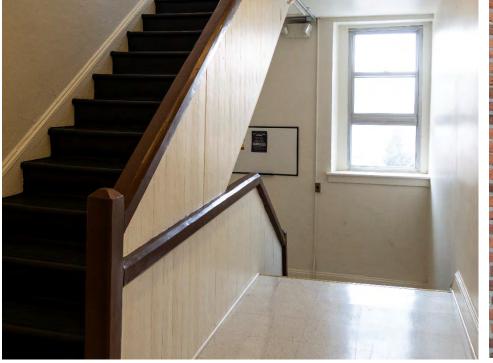
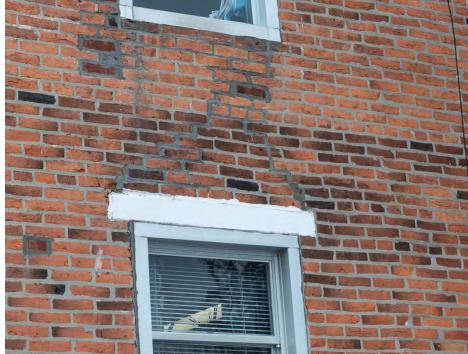
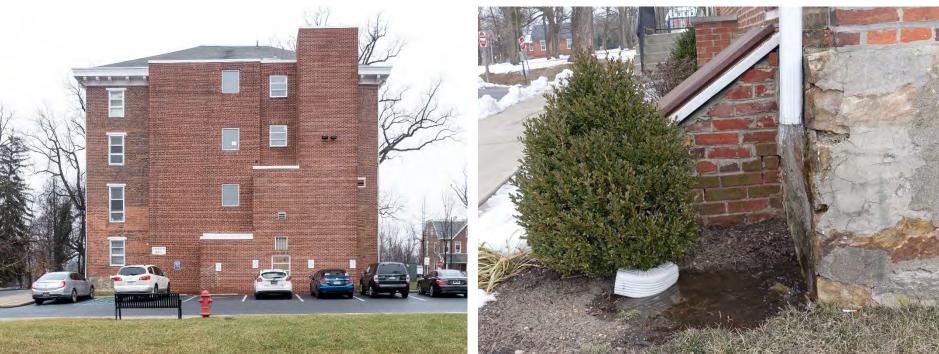
LINCOLN HALL CURRENT

Addition (1855-1954); Renovated c. 1960

Conditions:

- Roof nearing end of useful life
- Wood cornice requires repair
- Perimeter drainage issues
- Brick delamination
- Poor and missing mortar
- Incompatible windows, doors and rear addition

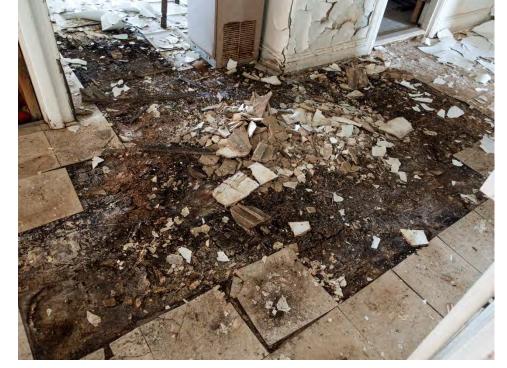
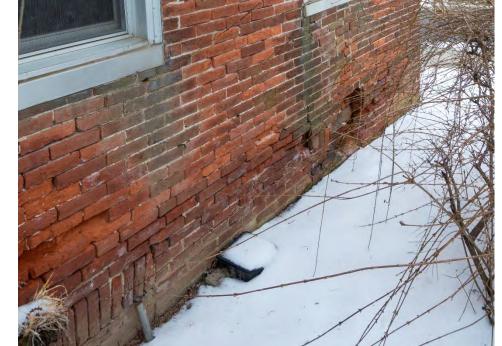
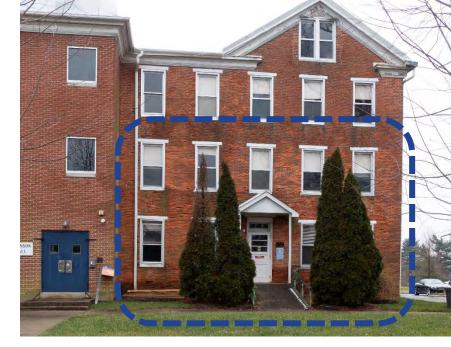
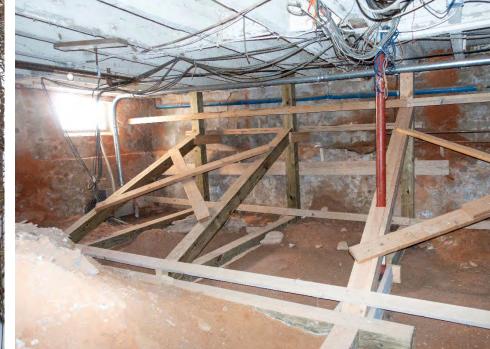
CRESSON HALL CURRENT

Constructed President's House 1856; Renovated 1962

Conditions:

- Full roof failure
- Brick delamination prevalent at north end and basement stabilization
- Poor and missing mortar
- Perimeter drainage issues
- Incompatible central, front elevation stair reclad c. 1962, windows and doors
- Wood cornice requires repair
- Full replacement of interior framing
- East wall stabilization

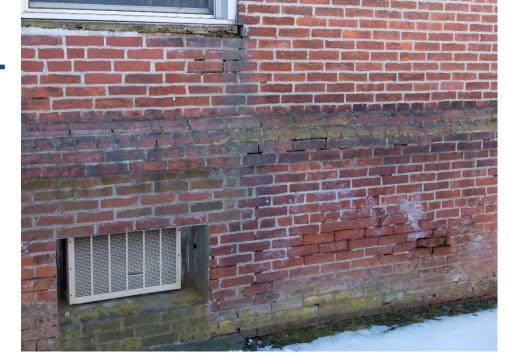
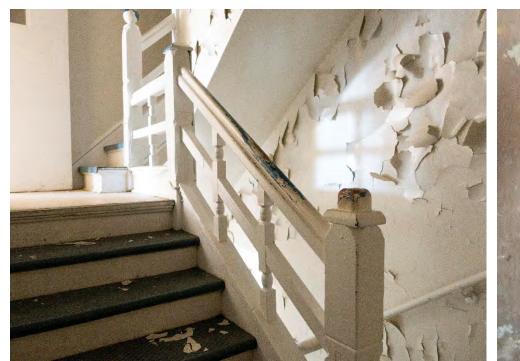
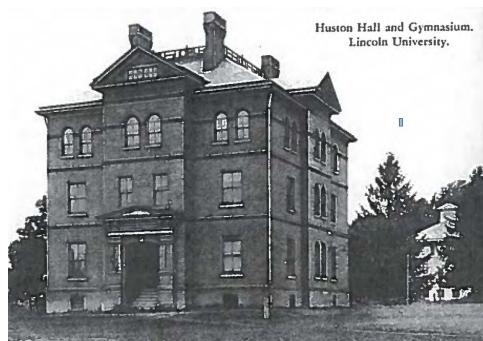
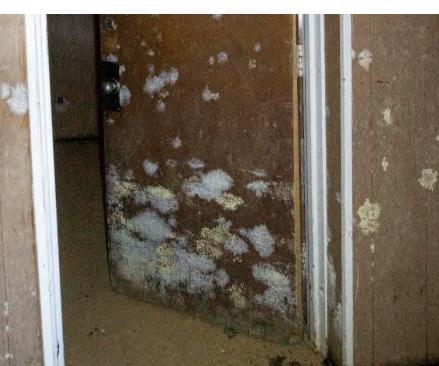
HOUSTON HALL CURRENT

Renovated c. 1960

Conditions:

- Failing roof flashing, misaligned gutters
- Brick settlement cracking, delamination, missing mortar
- Perimeter drainage issues
- Interior finish loss due to water infiltration flanking north, central projection
- Significant mold in basement
- Central stair requires stabilization

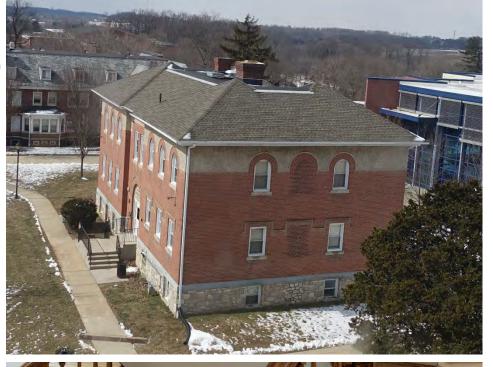
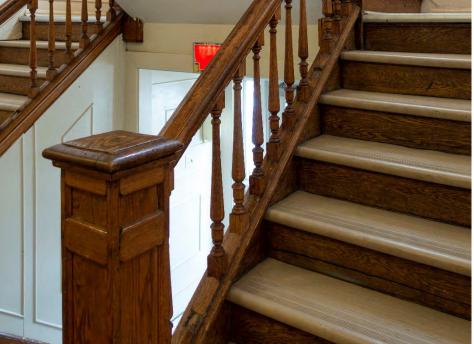
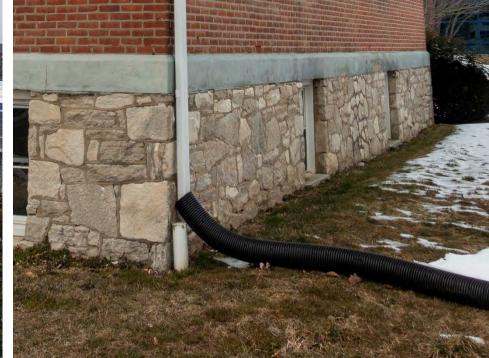
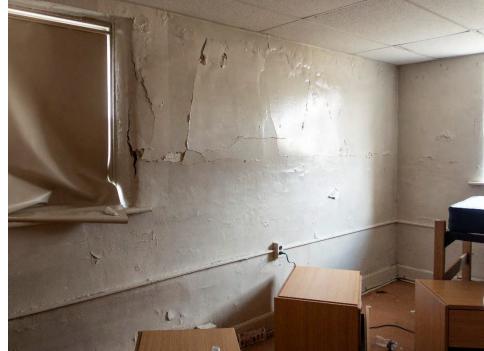
MCCAULEY HALL CURRENT

Renovated c. 1960

Conditions:

- Roof recently replaced
- Differential settlement at north corridor, 1st and 2nd Floors
- Limited step cracking at windows
- Perimeter drainage issues
- Water infiltration at basement resulting in plaster and mortar loss
- Central, rear elevation stair addition, c. 1960

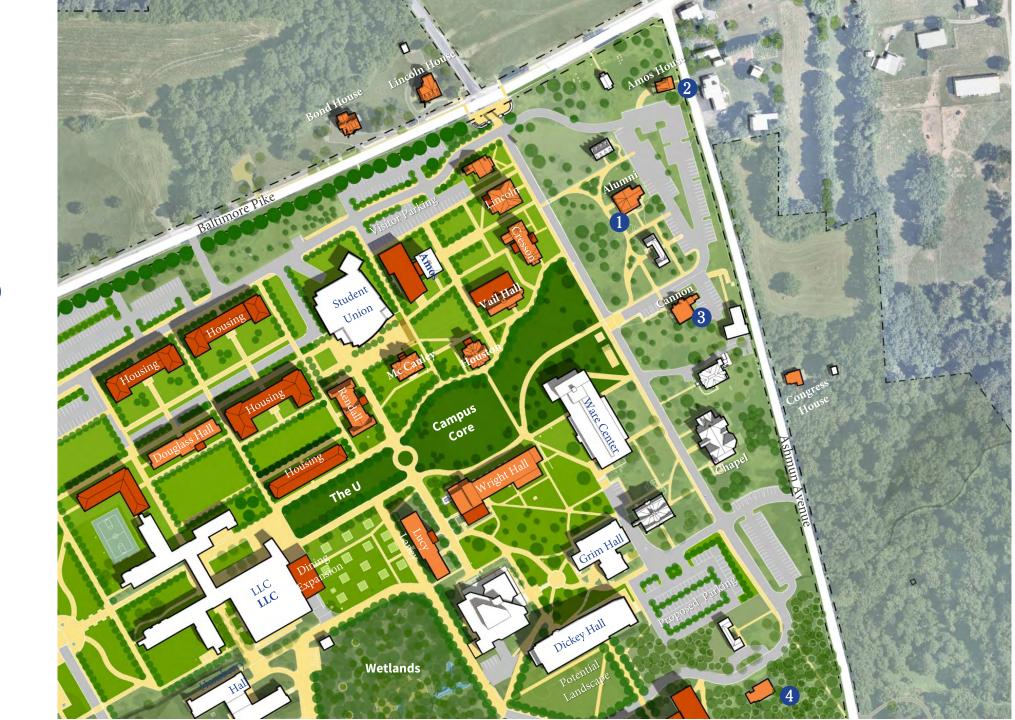
- 1. Alumni House (1870)
- 2. Amos Hall (c. 1871)
- 3. Cannon House (1874)
- 4. Danjuma African Art Center (1885)

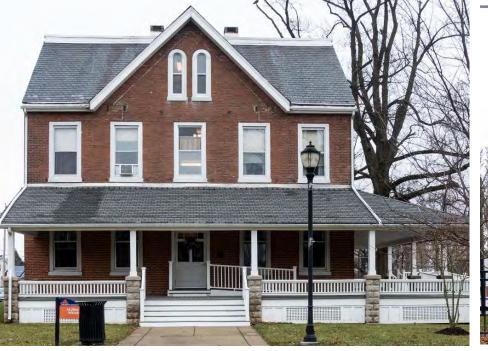
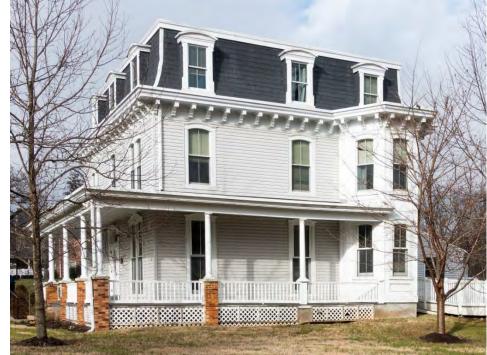
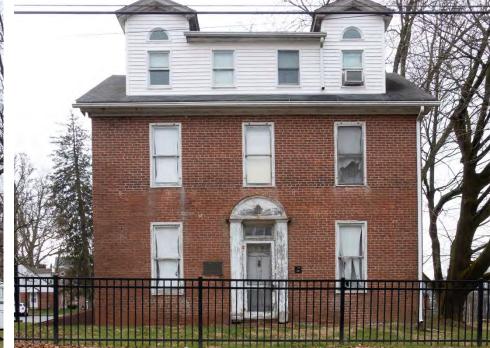
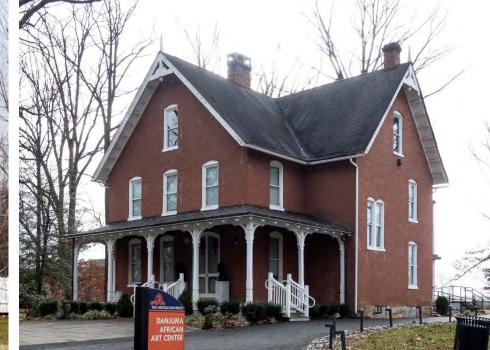
ON-CAMPUS RESIDENCES

Conditions:

- Amos is vacant
- Roofing in varying state of repair
- Perimeter drainage issues
- Brick delamination;
- Mortar loss
- Inappropriate windows, doors and stair additions
- Exterior woodwork repair
- Some interior finish loss

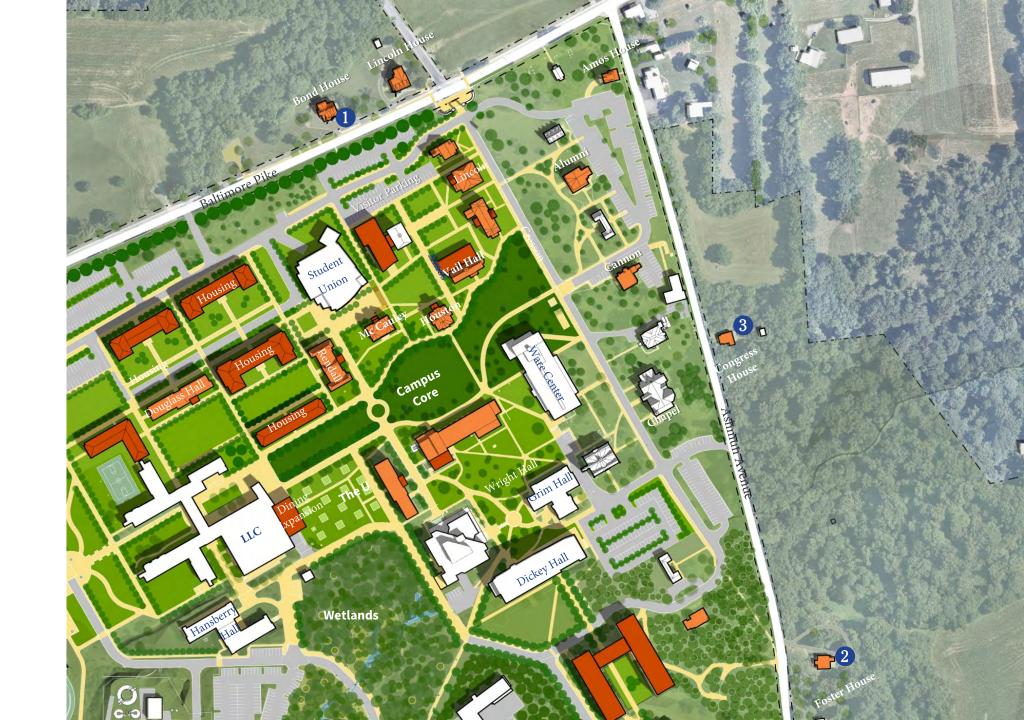
OFF CAMPUS RESIDENCES

- 1. Bond House (1891)
- 2. Foster House (1902)
- 3. Congress House (Unknown)

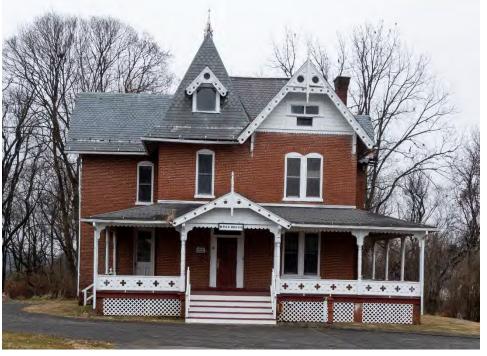
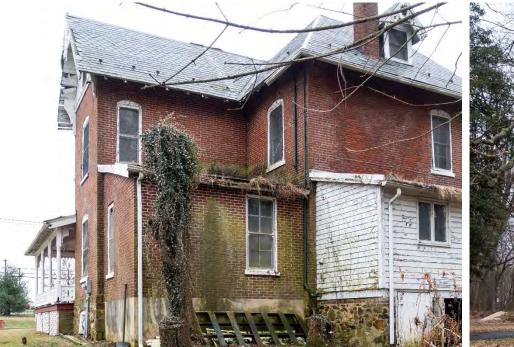
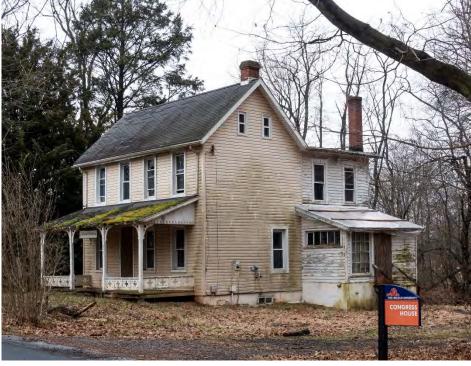
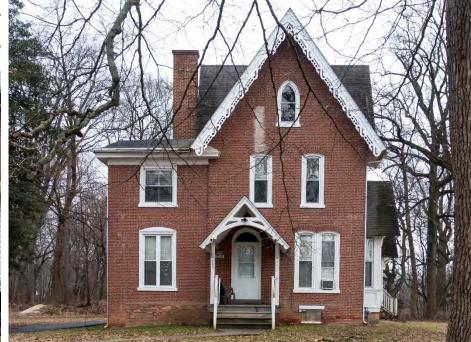
OFF CAMPUS RESIDENCES

Conditions:

- Bond and Congress are vacant
- Roofing, gutters and downspouts in varying state of repair / failure
- Perimeter drainage issues
- Brick delamination
- Mortar loss
- Porches and woodwork require repair
- Some interior finish loss

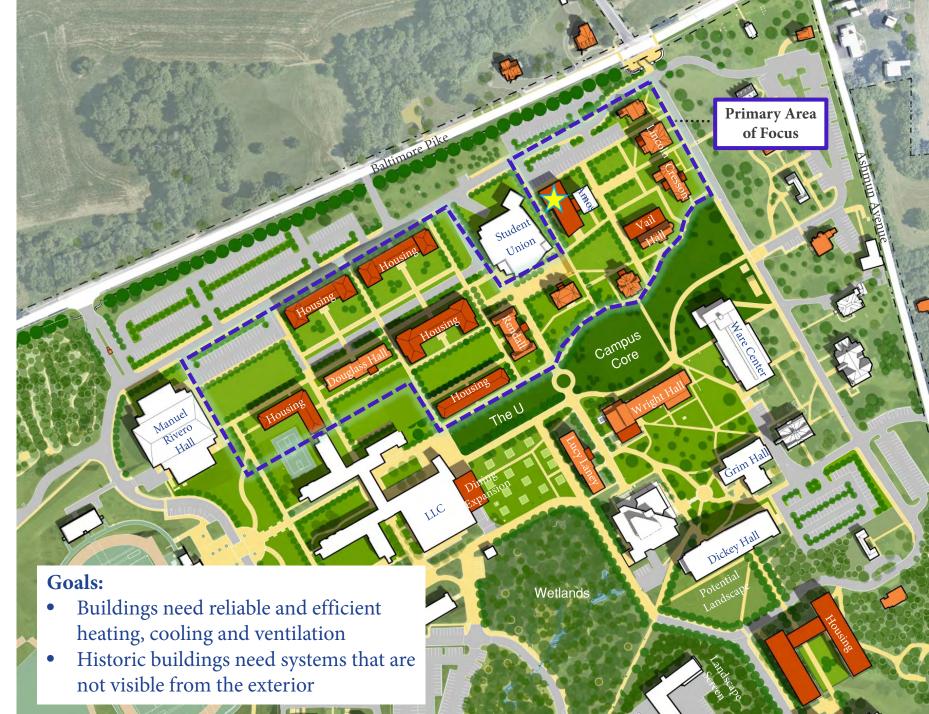
MEP SYSTEMS

ELECTRICAL

- Infrastructure service equipment and site distribution systems replaced within the last 15 years and in good condition
- Emergency generators operate well individually
- Emergency system controls, monitoring, and output display systems are not complete or integrated
- Recommendation relocate unnecessary emergency generators to locations of greater need and remove any unneeded ones.

COOLING

- Building cooling is a combination of air-cooled, packaged DX, VRF and window units
- Some buildings are not cooled
- Utility tunnel is too small to provide for a chilled water system so a district system for the existing buildings is not recommended
- Recommendation magnetic bearing chillers for future buildings and HVAC upgrades

HEATING

- District steam serves most buildings
- Plant and distribution system can support growth
- Recommendation monitor the condensate piping system and budget for its replacement
- Recommendation connect all campus buildings that are near the existing distribution system to the central system

HISTORIC & RESIDENTIAL DISTRICTS

Recommendations

- Supply all historic with a small hot and chilled water geoexchange plant located in the Amos addition
- Connect Frederick Douglass to one of the new residential buildings for hot and chilled water
- Every new residential building to be served by dedicated aircooled chillers or DX cooling with roof-top air handling units
- New buildings may connect to campus steam to generate building heating hot water or generate their own hot water via condensing high-efficiency boilers
