# Lincoln University

## Campus Master Plan

Workshop 4 – Steering Committee  
June 27, 2019

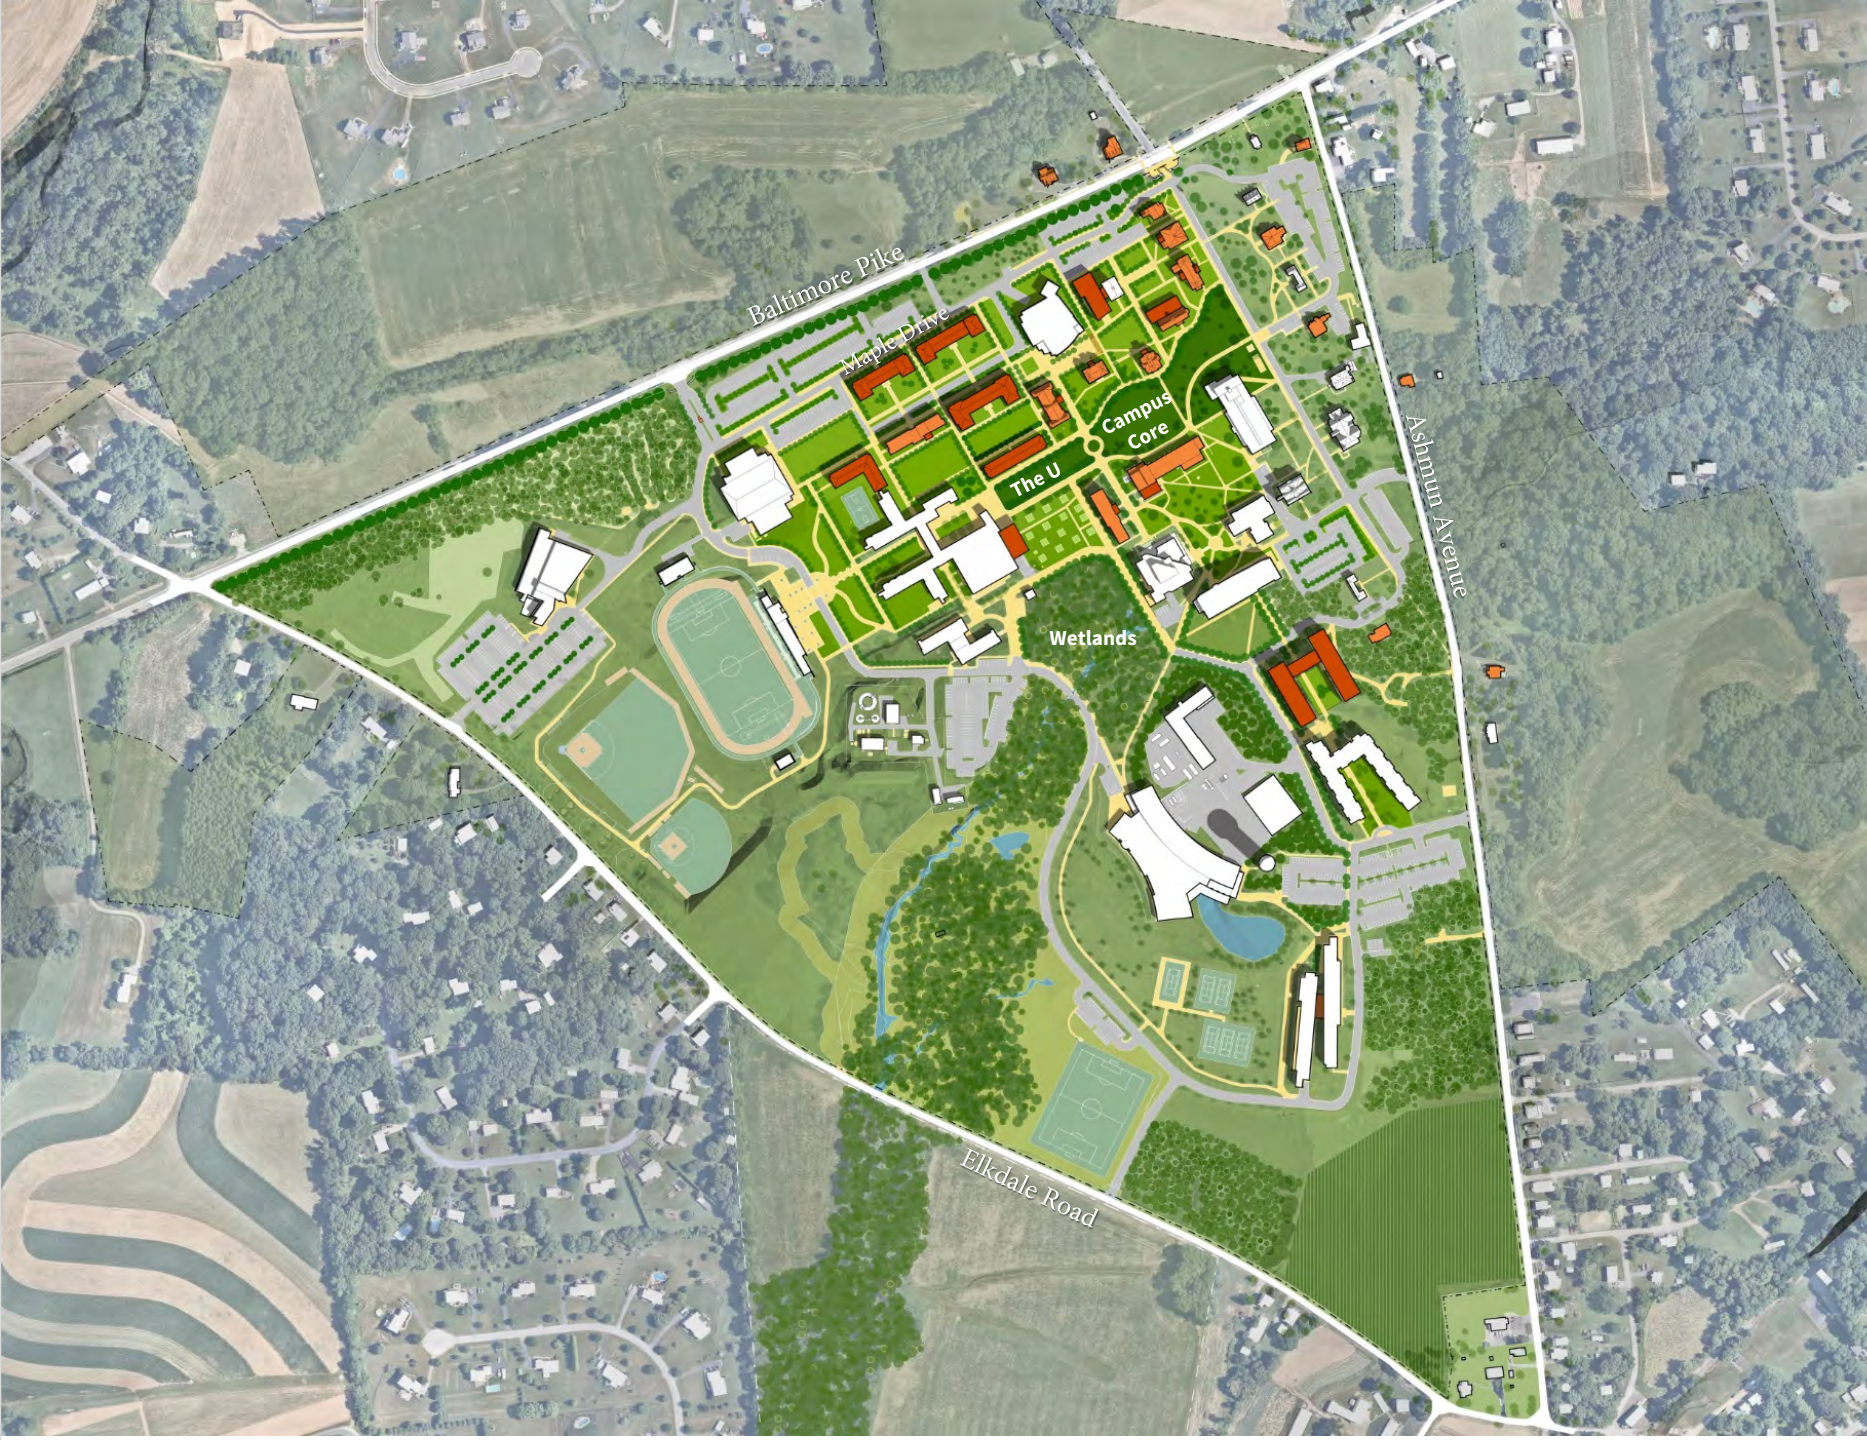
# FUTURE CAMPUS PLAN

New construction
-

Renovation
-

Existing Building

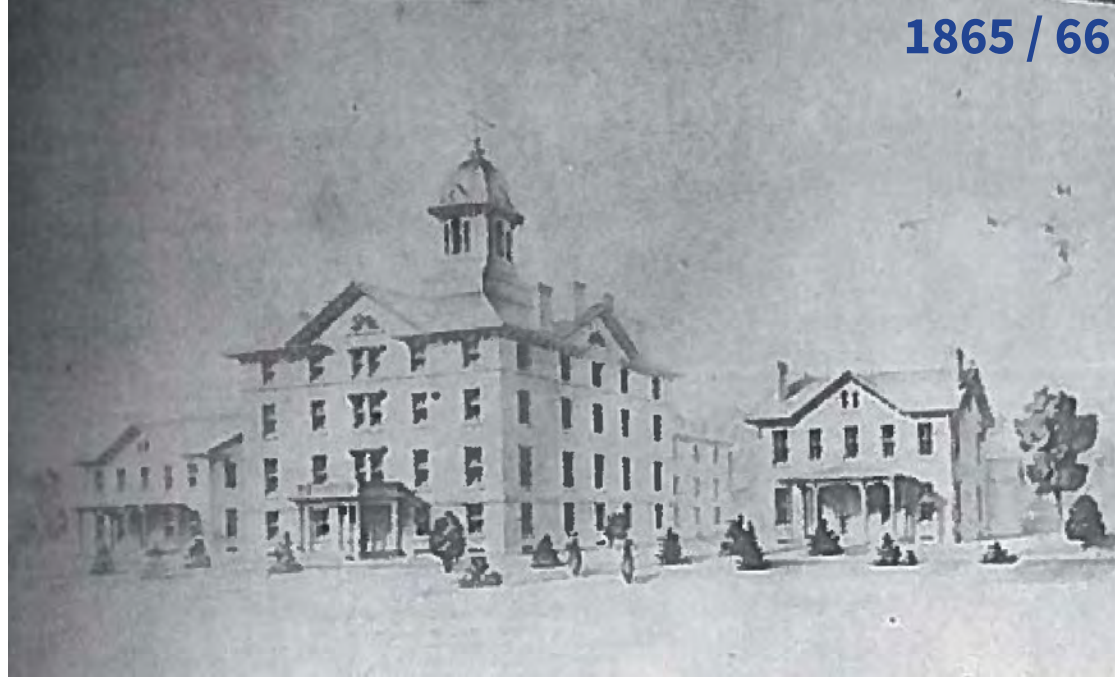
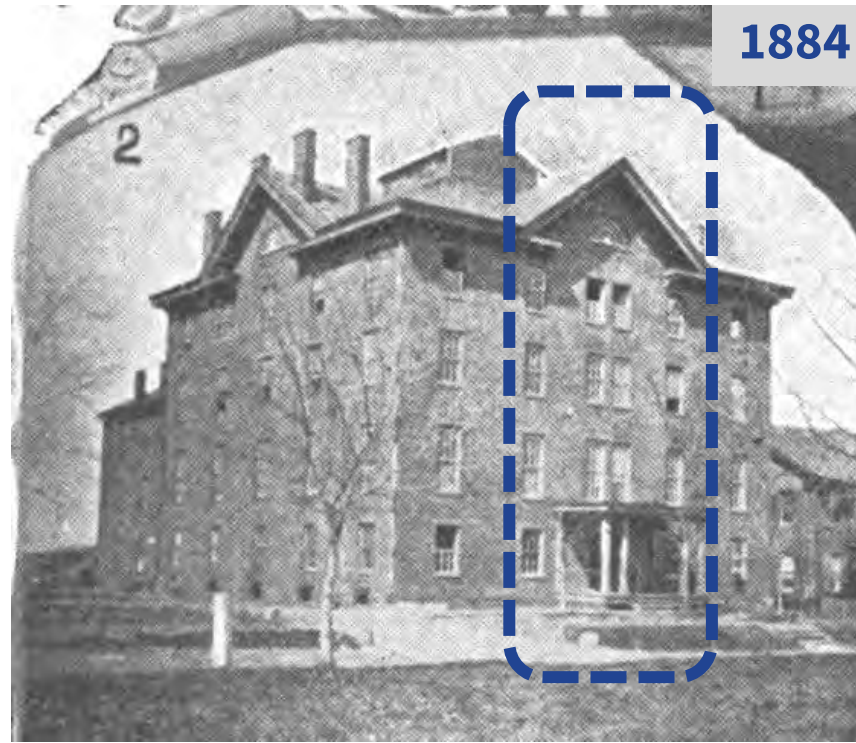
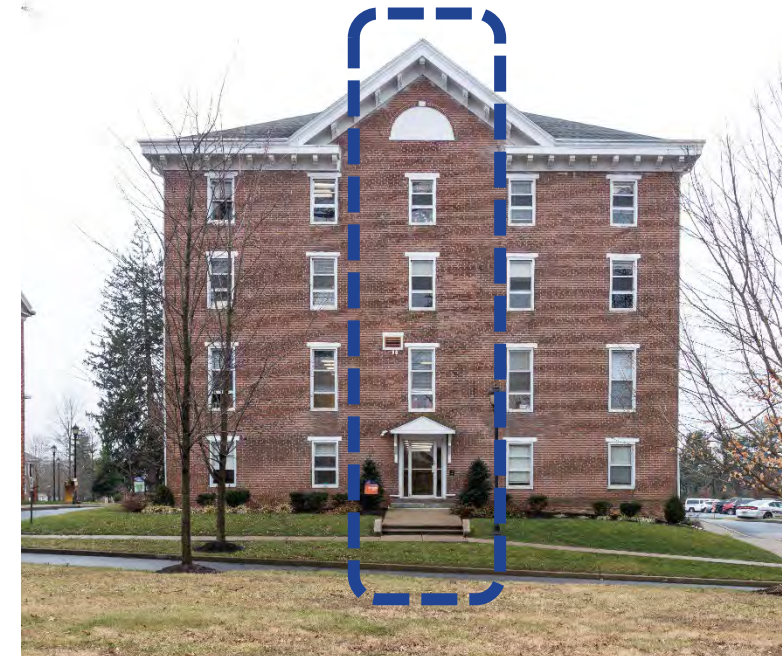
# LINCOLN HALL HISTORY

- Constructed 1866 – Addition to Ashmun Hall 1854-1954
- Remolded 1961/62
- Historic Uses: Dormitory for 95 Students, Society Halls and Library
- Missing Historic Features: Windows; Central paired window openings and entrance porch; Chimneys; Flat roof projection (bell tower?)

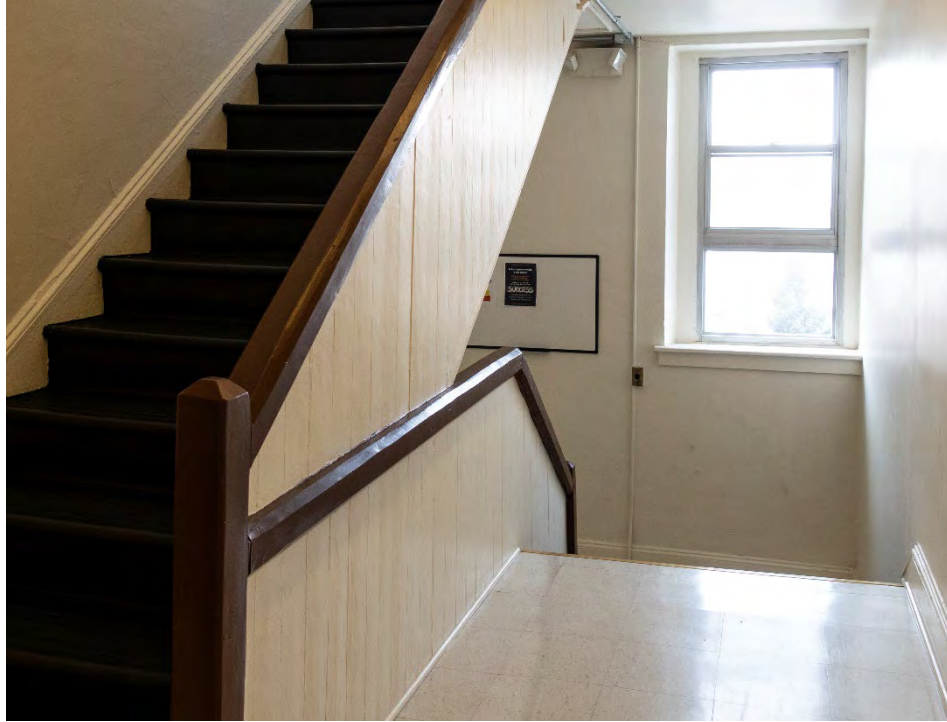
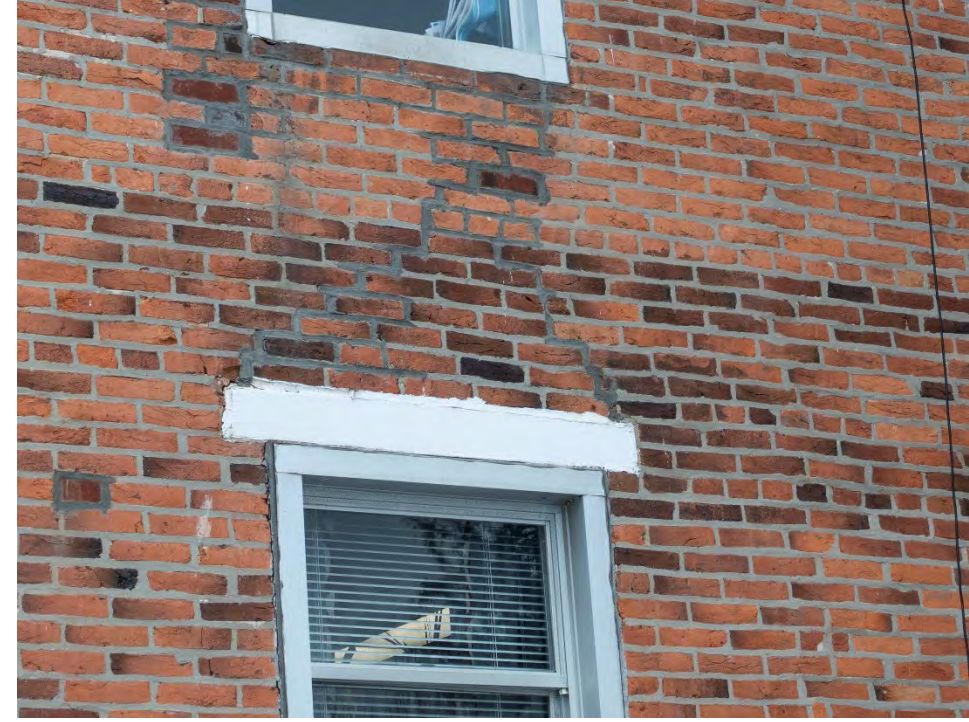
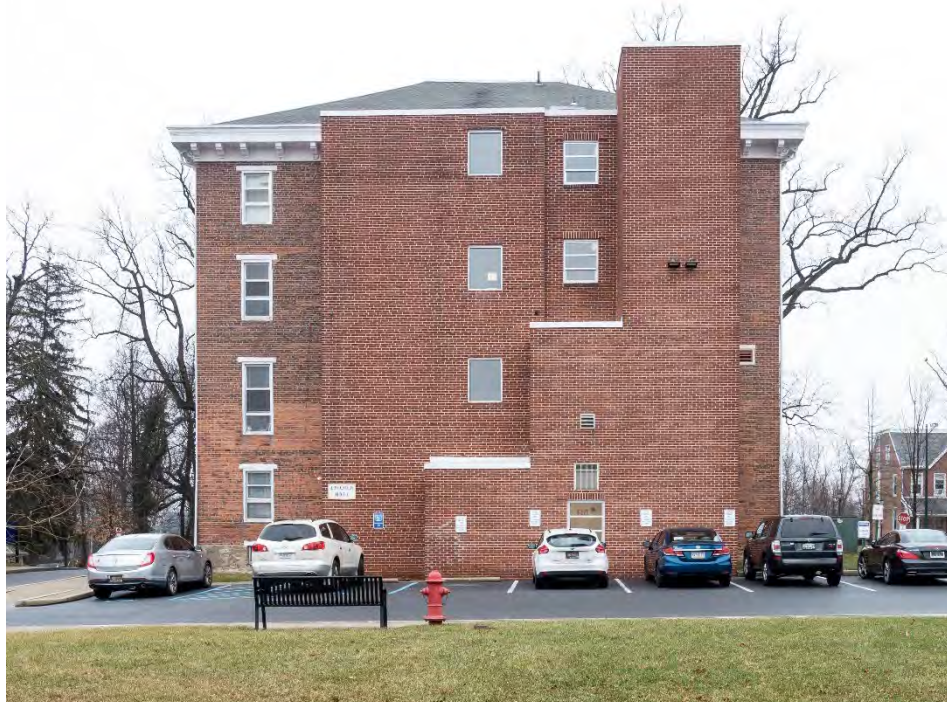
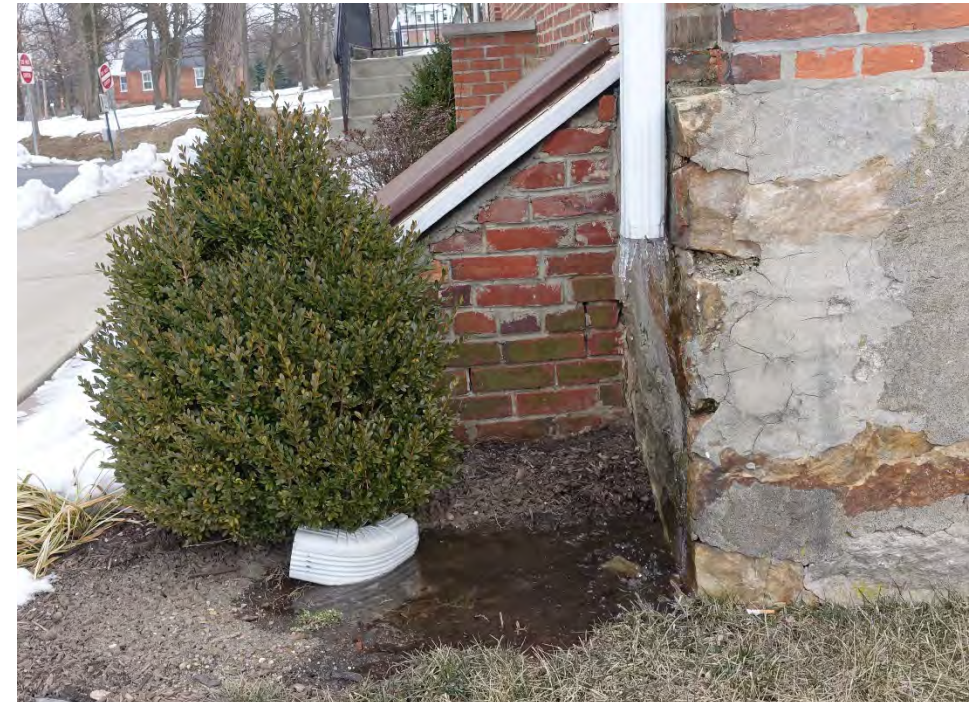
# LINCOLN HALL CURRENT

Use: Administrative Offices

## Conditions:

- Brick delamination
- Poor and missing mortar
- Perimeter drainage issues
- Incompatible rear addition

## Interior Historic Features:

- Stairway

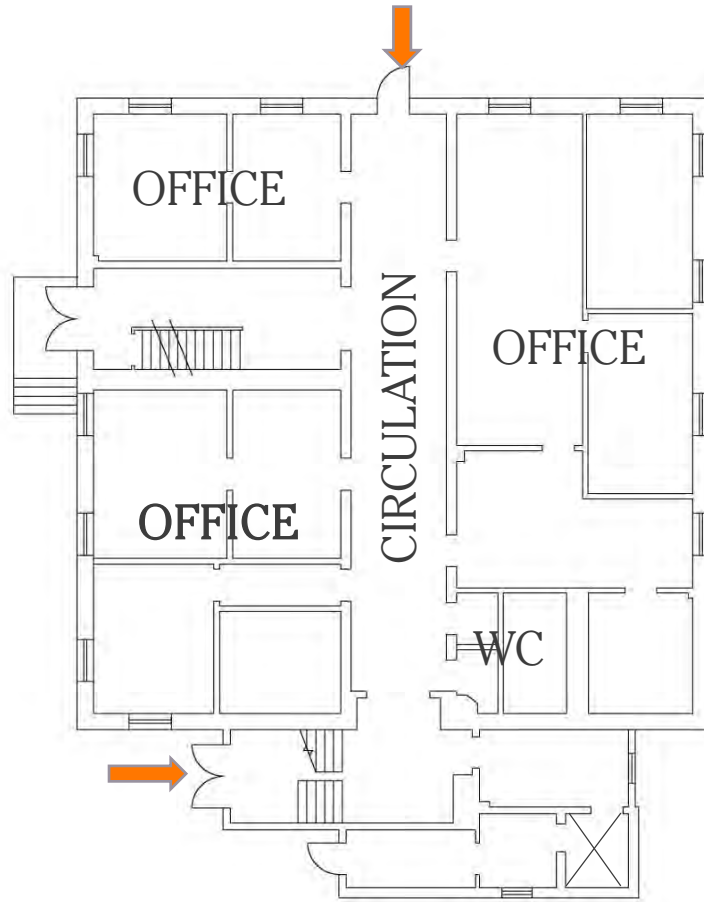
## EXISTING GROUND PLAN

# POTENTIAL USE CONCEPTUAL PLAN – Admin & One-Stop

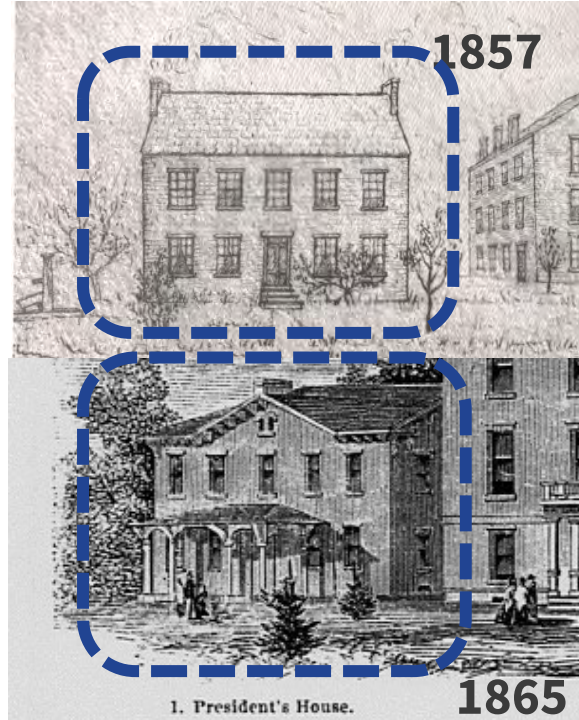
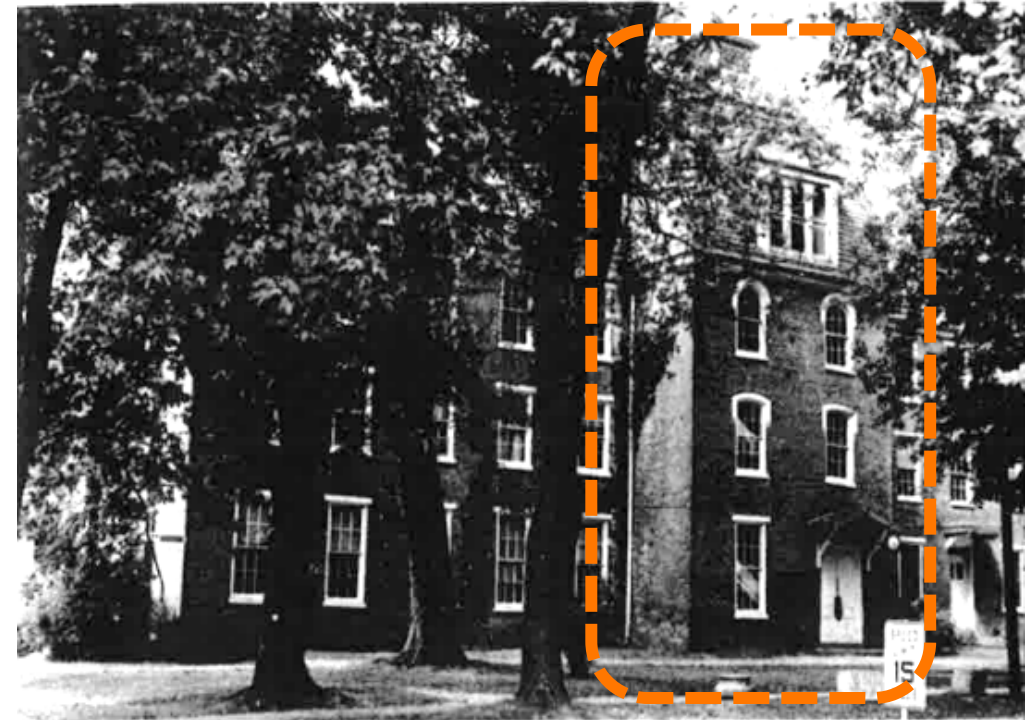
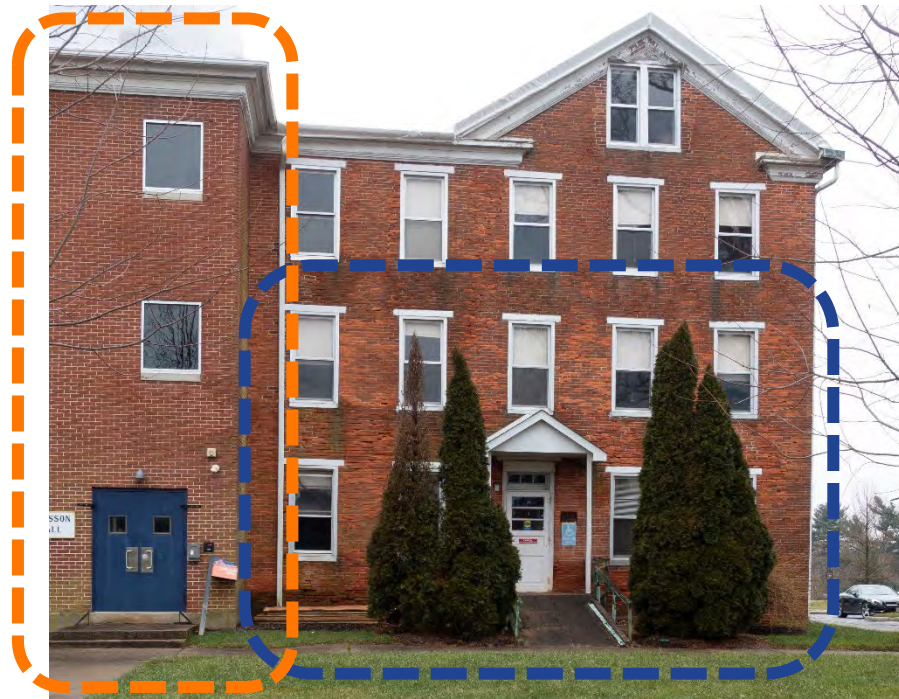
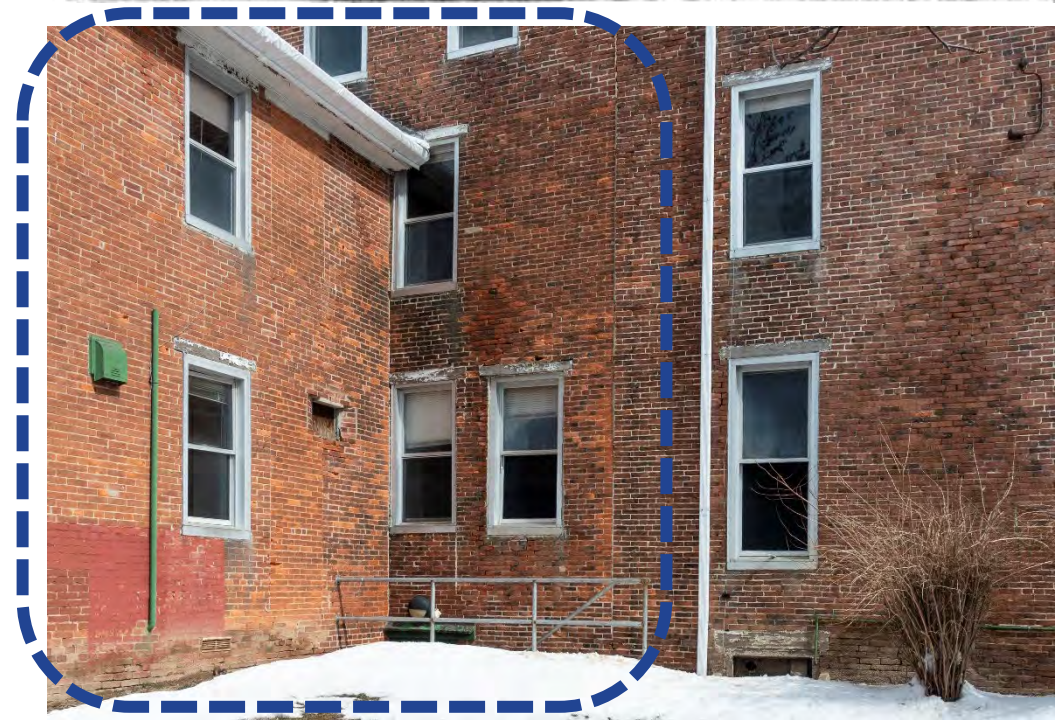
# CRESSON HALL HISTORY

- Constructed 1870;  
Renovated 1962
- Potentially encompasses original President's House at north
- Historic Uses: Dormitory for 80 Students, three Boarding Clubs and the Chemical Laboratory; Library and Reading Room
- Missing Historic Features: Windows; Central stair fenestration; (Roof features concealed)

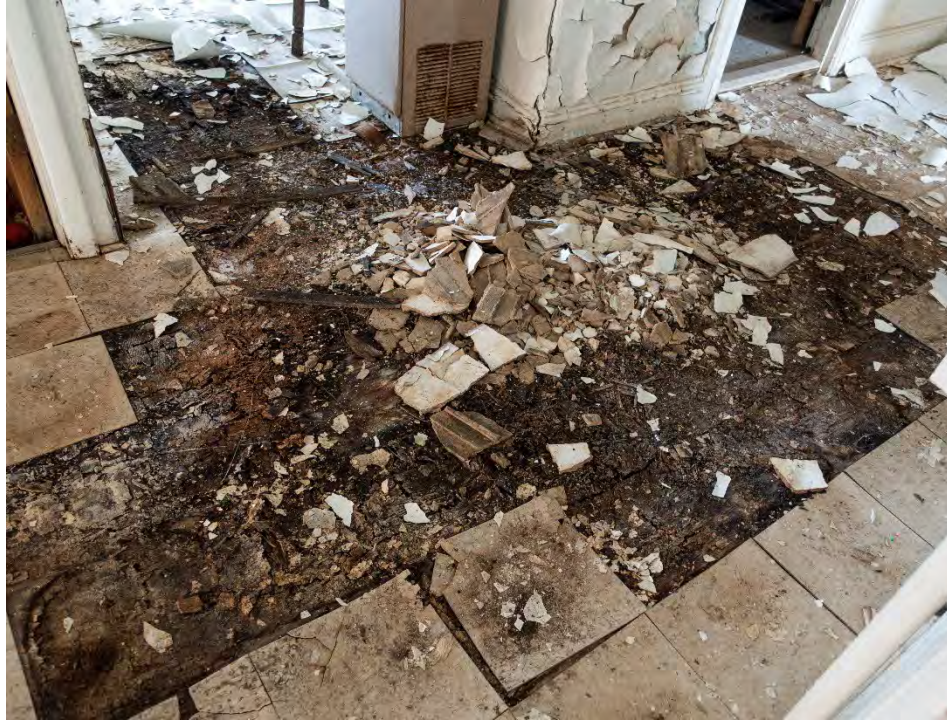
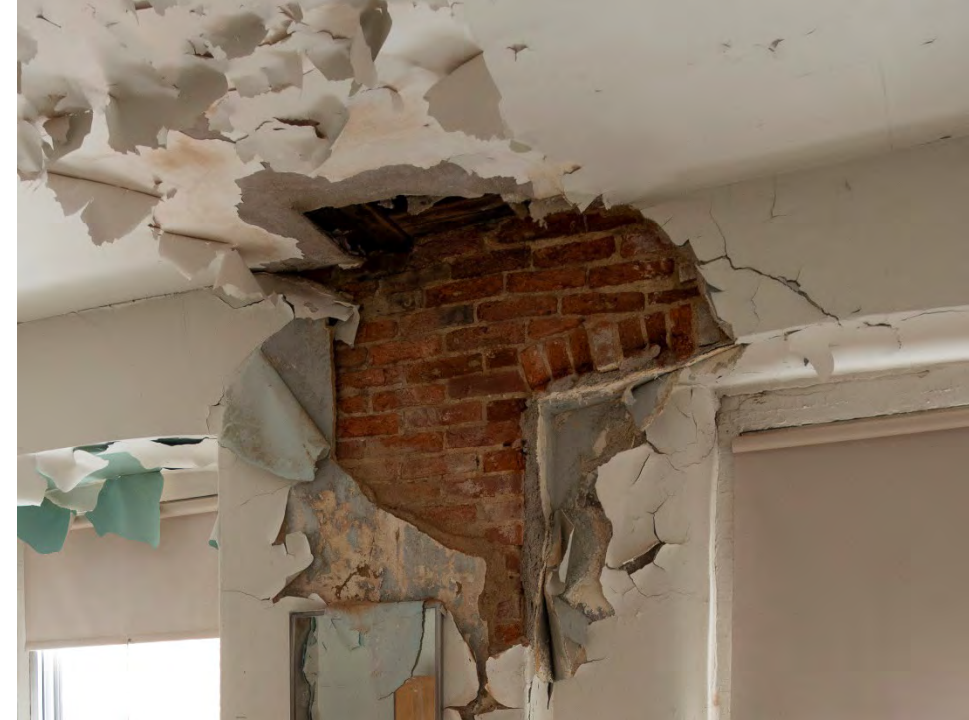
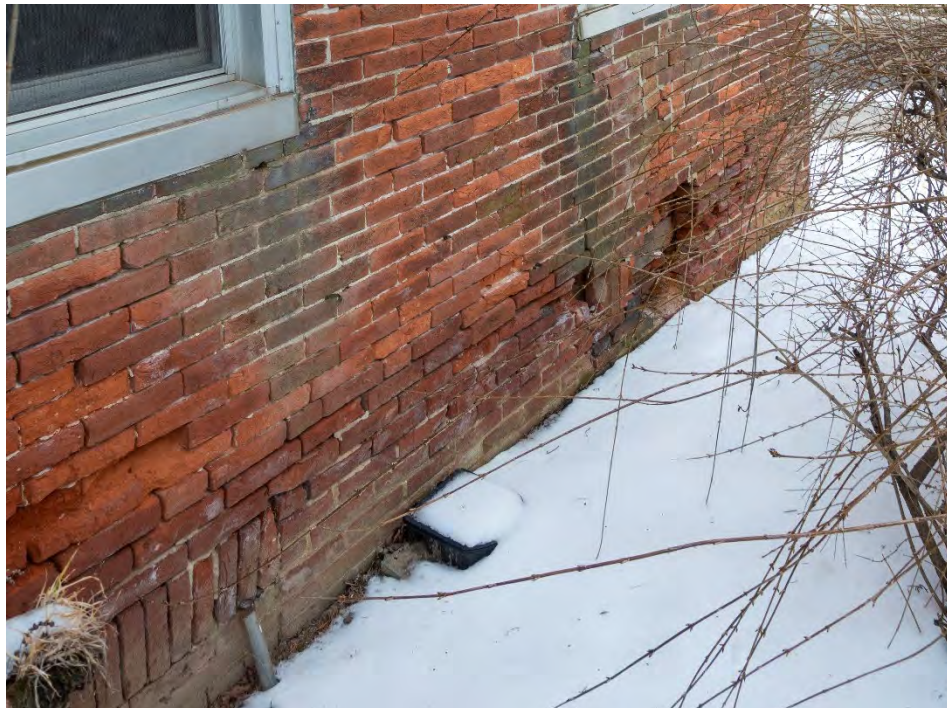
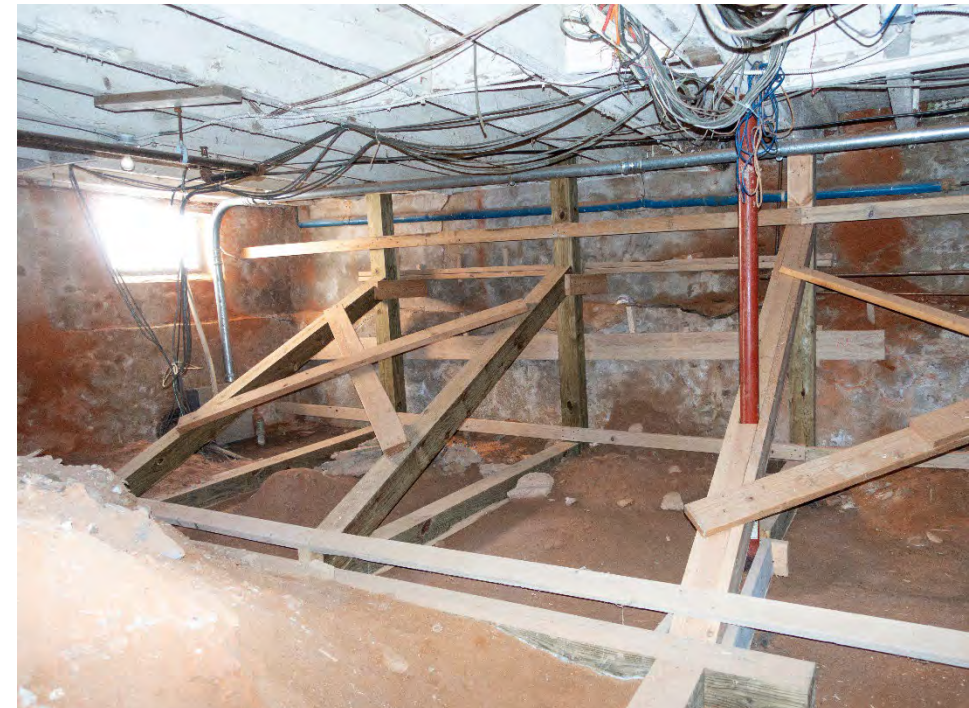
# CRESSON HALL CURRENT

Use: Vacant

## Conditions:

- Opening in roof stabilized with temporary sheathing
- Structurally compromised floor system – significant deflection and water damage
- Brick delamination prevalent at north end and basement stabilization
- Significant mortar loss
- Perimeter drainage issues
- Central, front elevation stair re-clad c. 1962

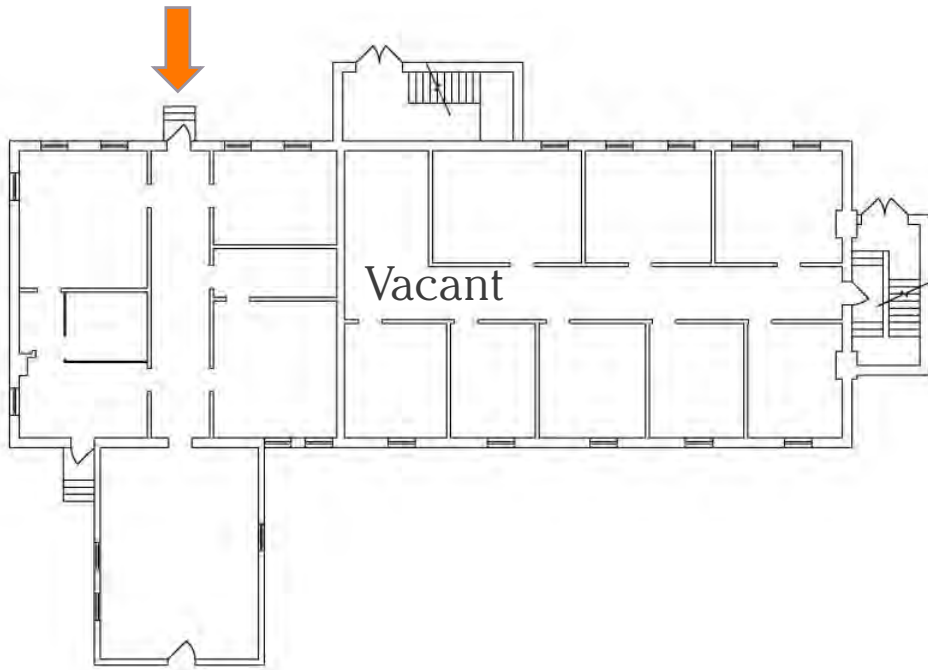
## EXISTING GROUND PLAN

# POTENTIAL USE CONCEPTUAL PLAN

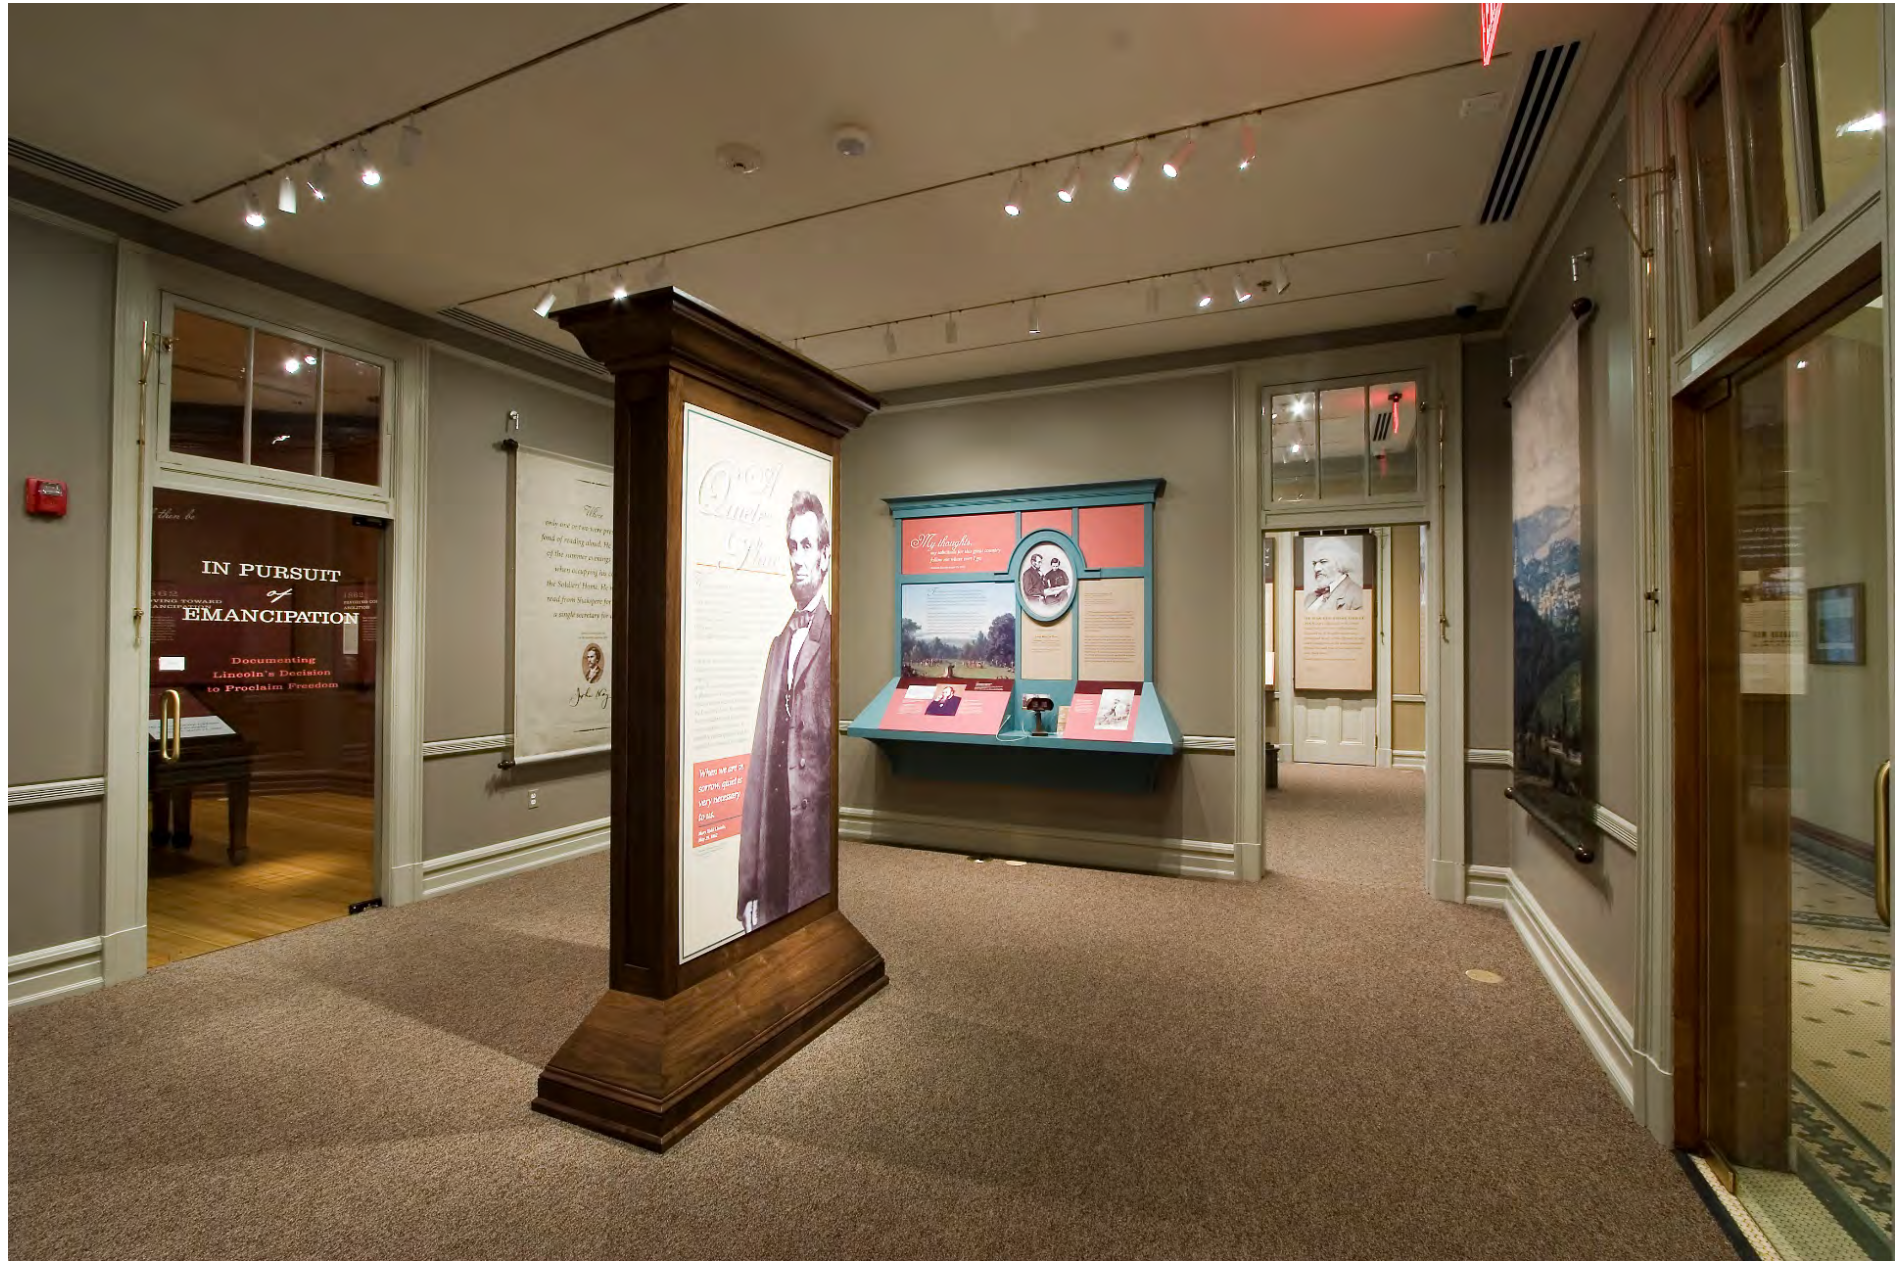
# TELL THE LINCOLN STORY

A space highlighting the history of Lincoln could be provided adjacent to the Admissions Center

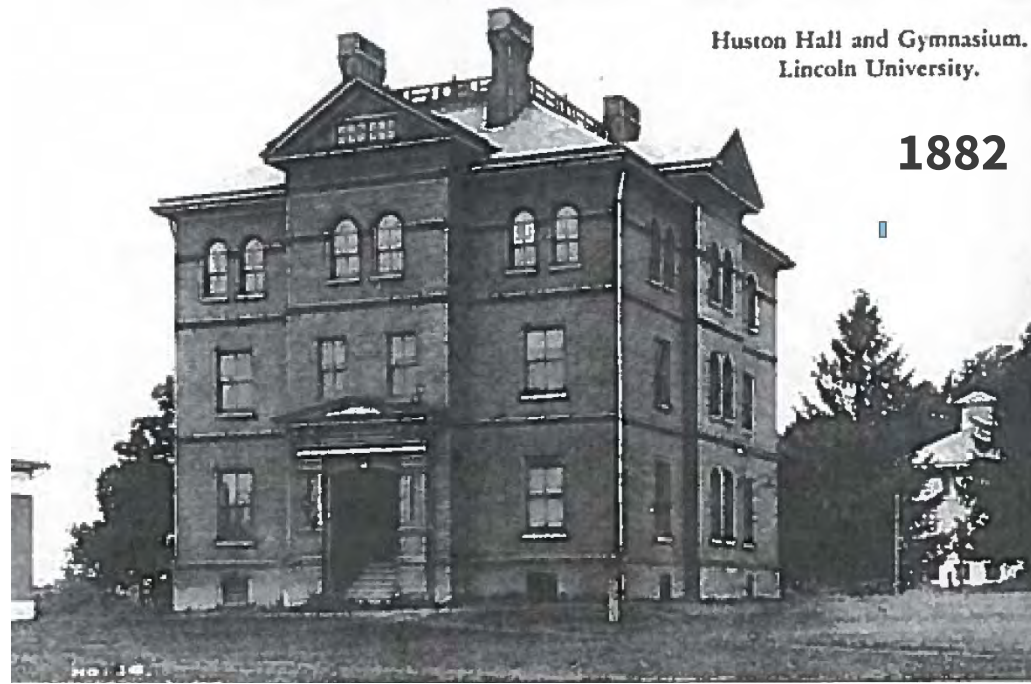
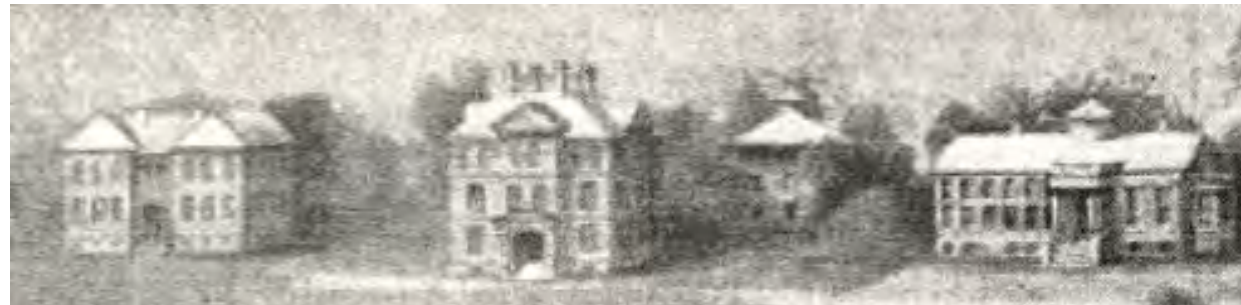
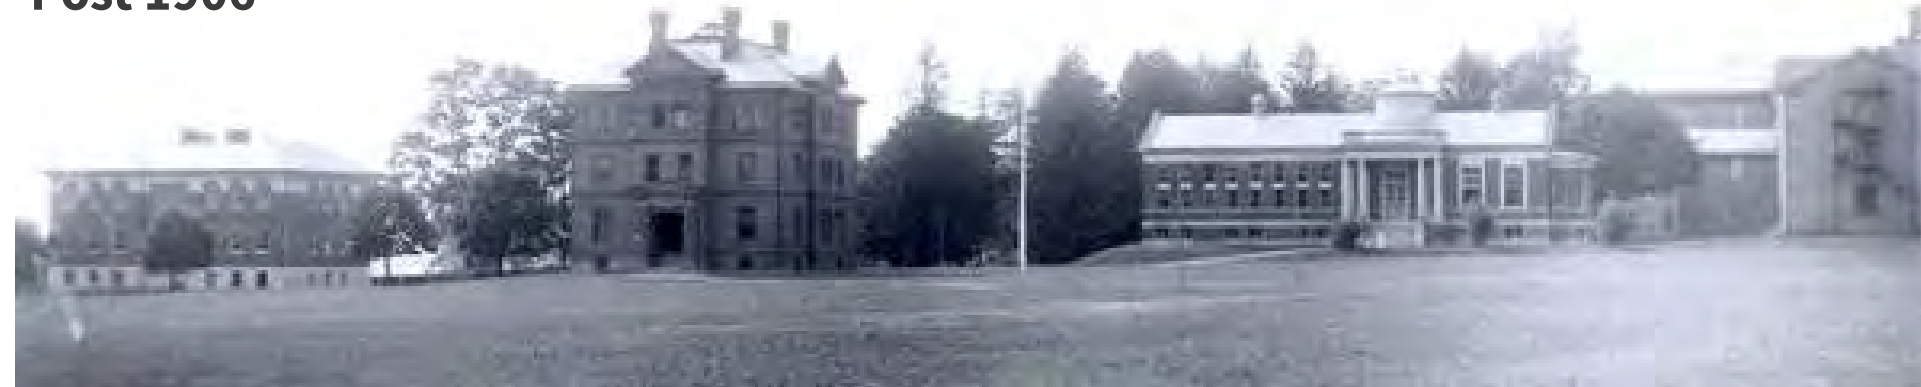
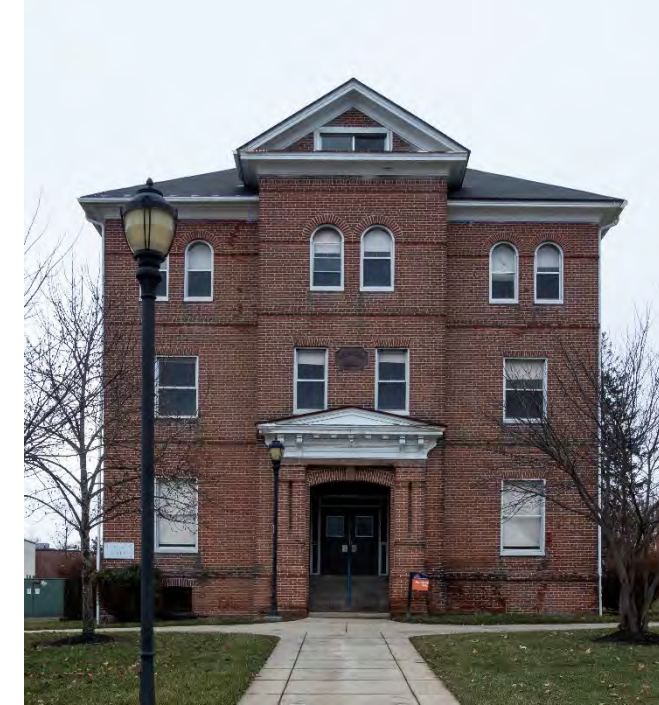
# HOUSTON HALL HISTORY

- Constructed 1881-82;  
Renovated 1960
- Historic Uses:  
Dormitories for  
Theological Students,  
quarters of the  
Theological and  
Missionary societies until  
1959; Later Dormitory
- Missing Historic Features:  
Windows; Chimneys;  
Widows Walk

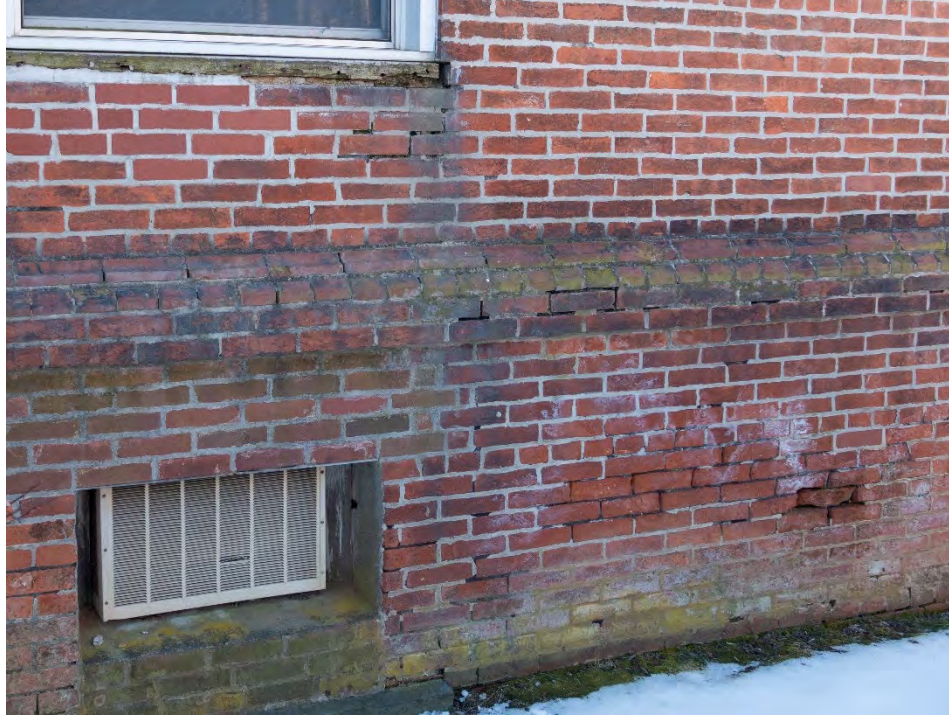
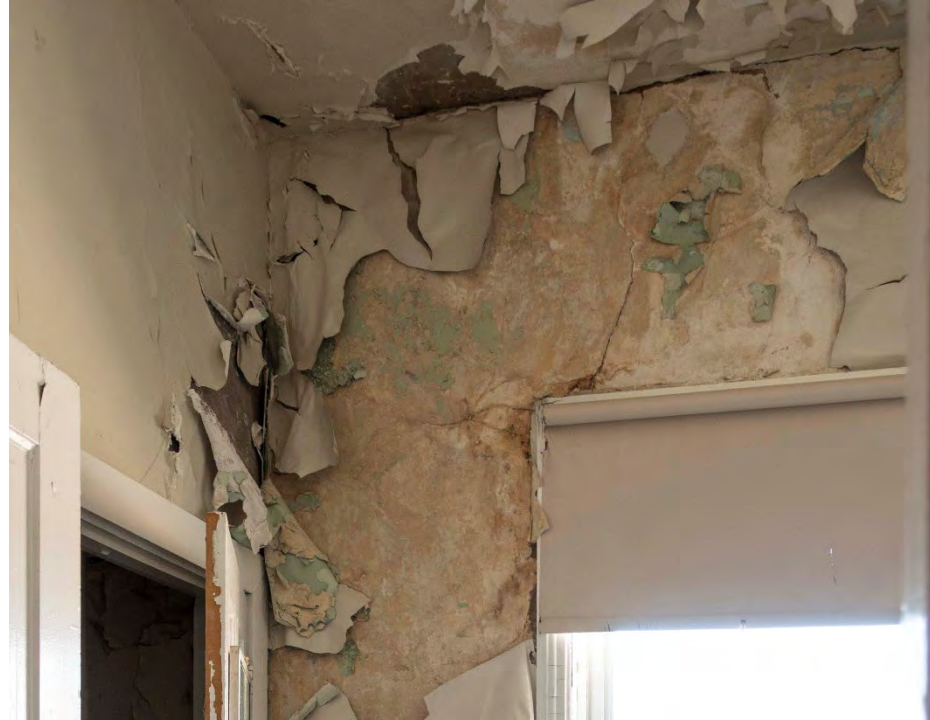
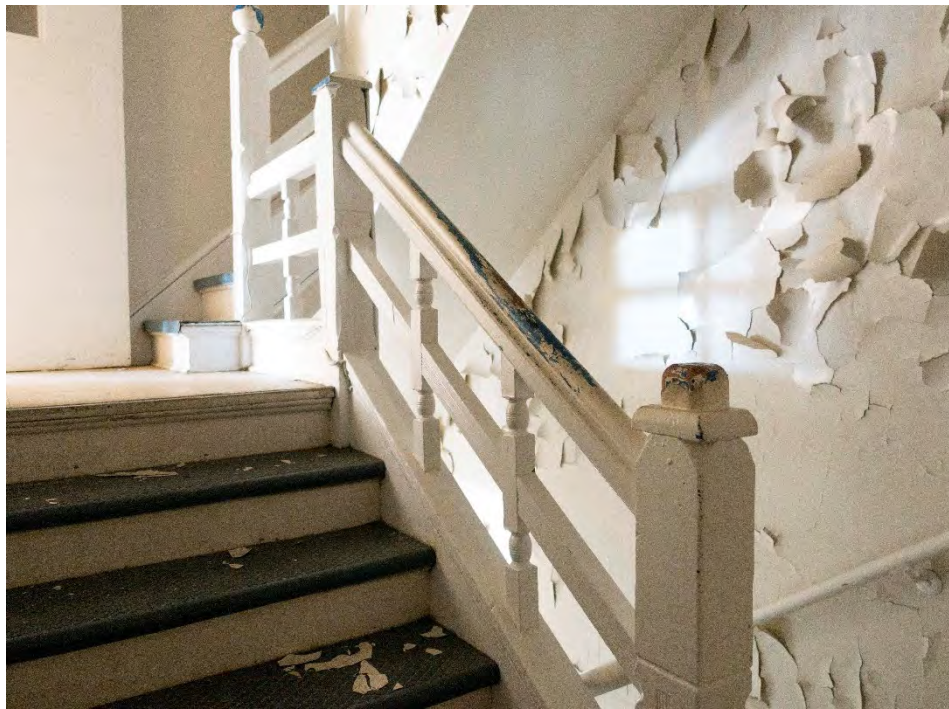
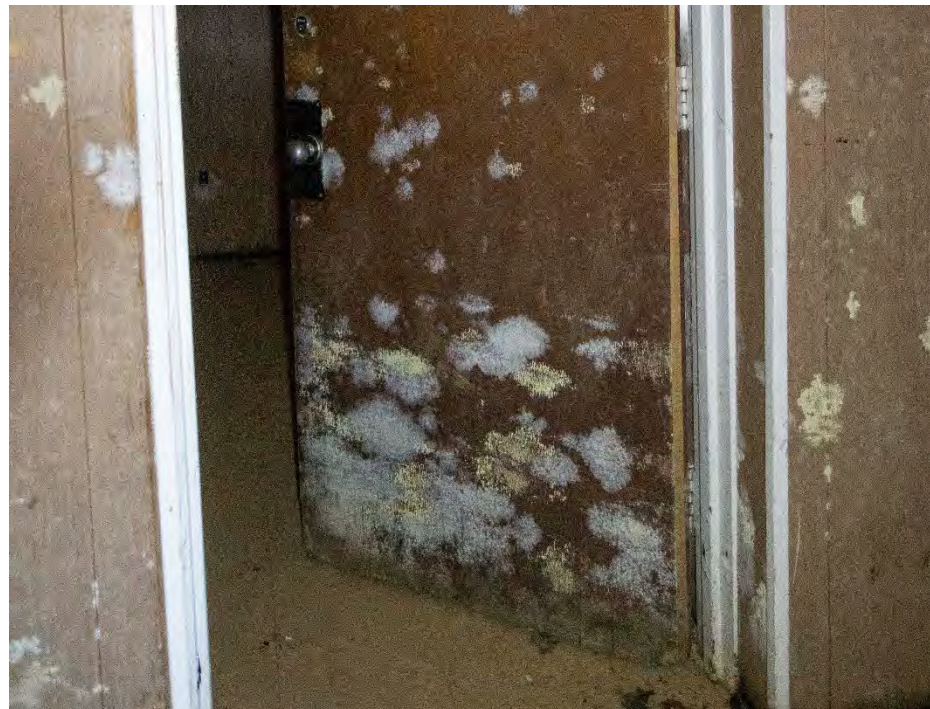
# HOUSTON HALL CURRENT

Use: Vacant

## Conditions:

- Brick settlement cracking, delamination, missing mortar
- Failing roof flashing, misaligned gutters
- Finish loss due to water infiltration flanking north, central projection
- Perimeter drainage issues
- Significant mold in basement
- Central stair requires stabilization

## Interior Historic Features:

- Central stair
