# Lincoln University

## Campus Master Plan

Workshop 4 – Steering Committee  
June 27, 2019

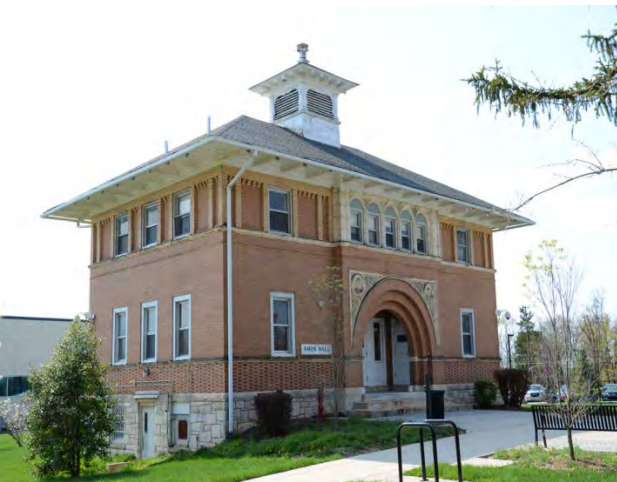
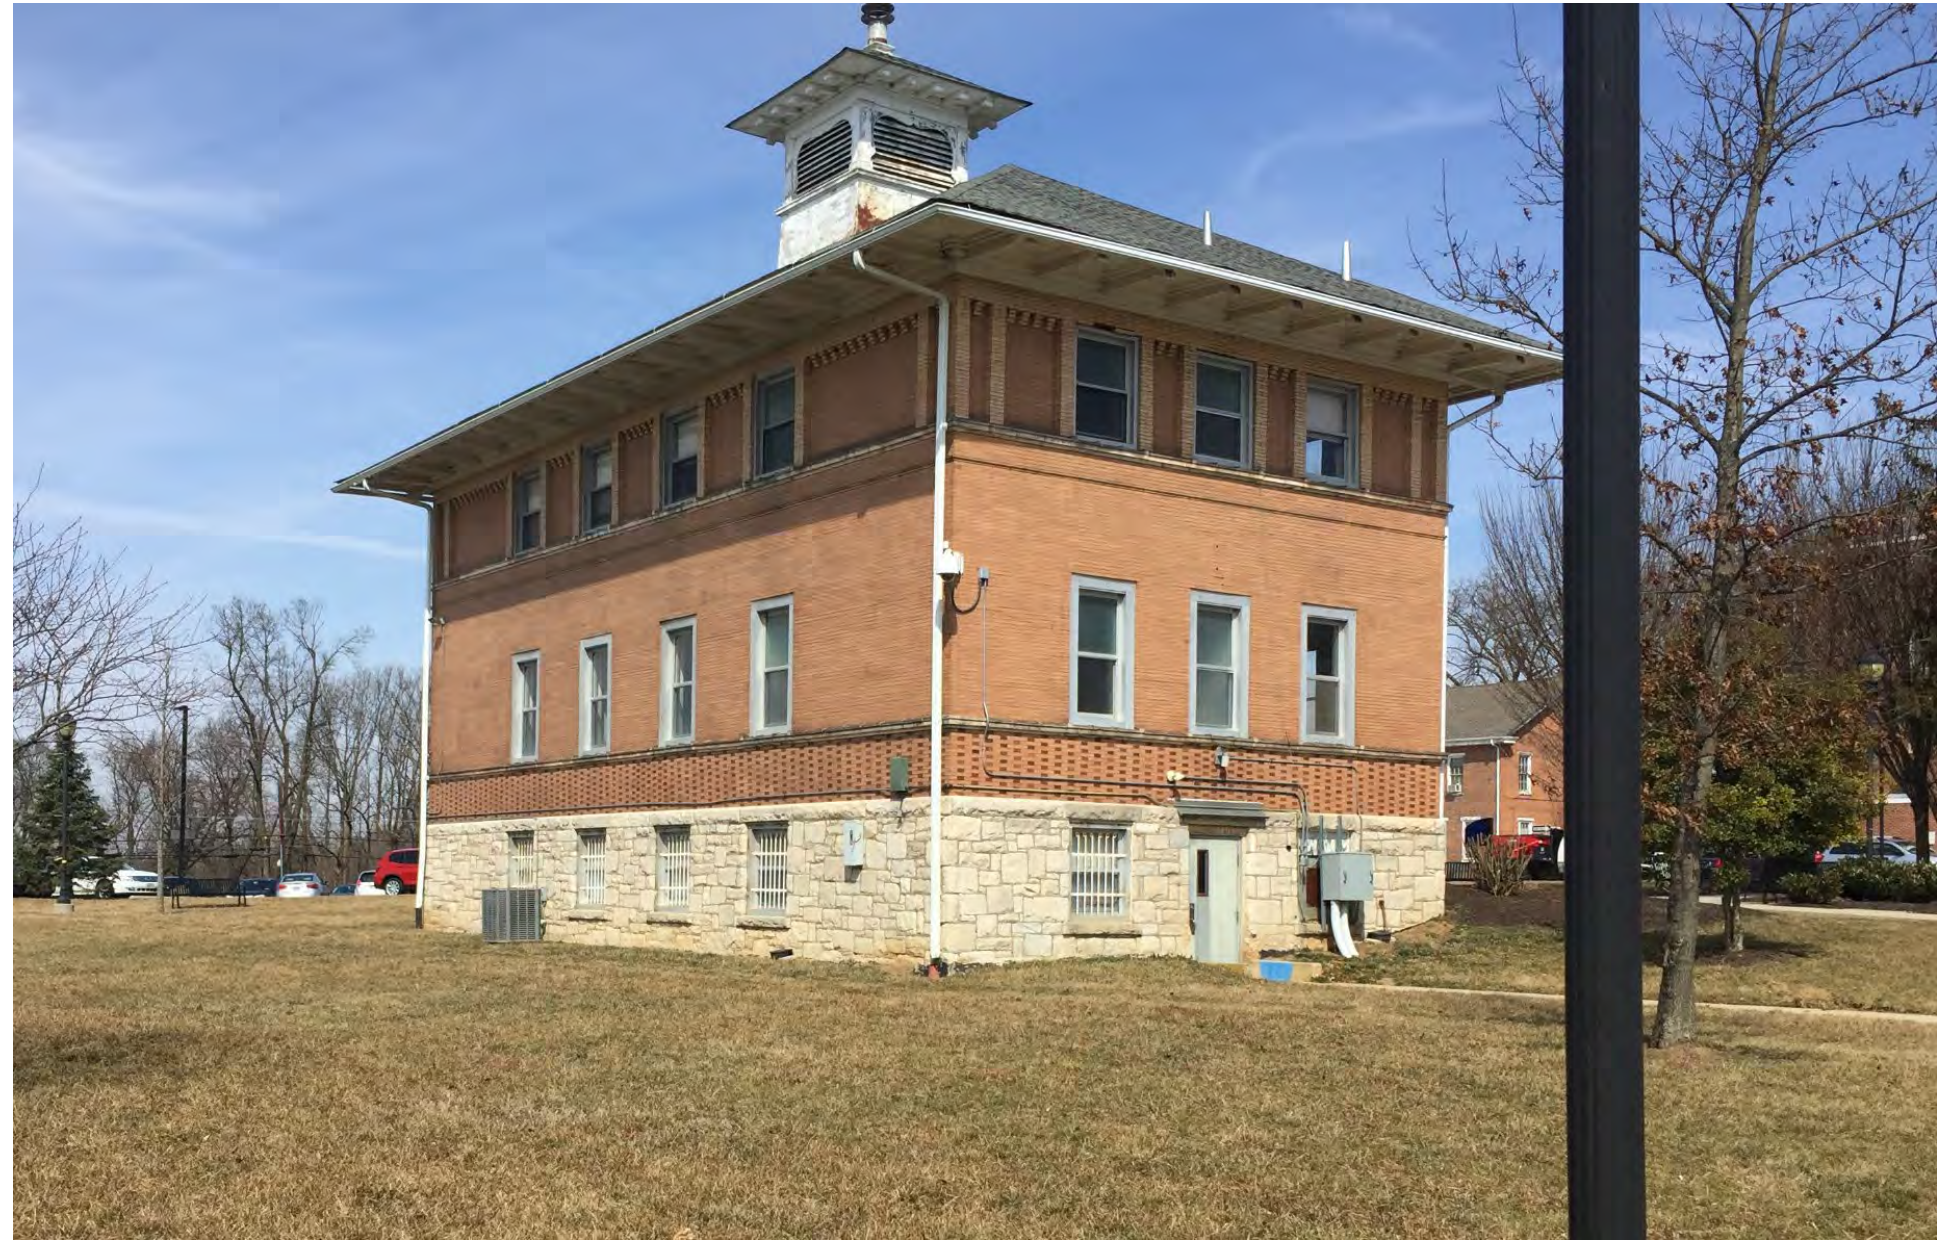
# AMOS HALL

**CONSTRUCTED 1902**

**Original uses: Bathhouse**

**Total SF 3390**

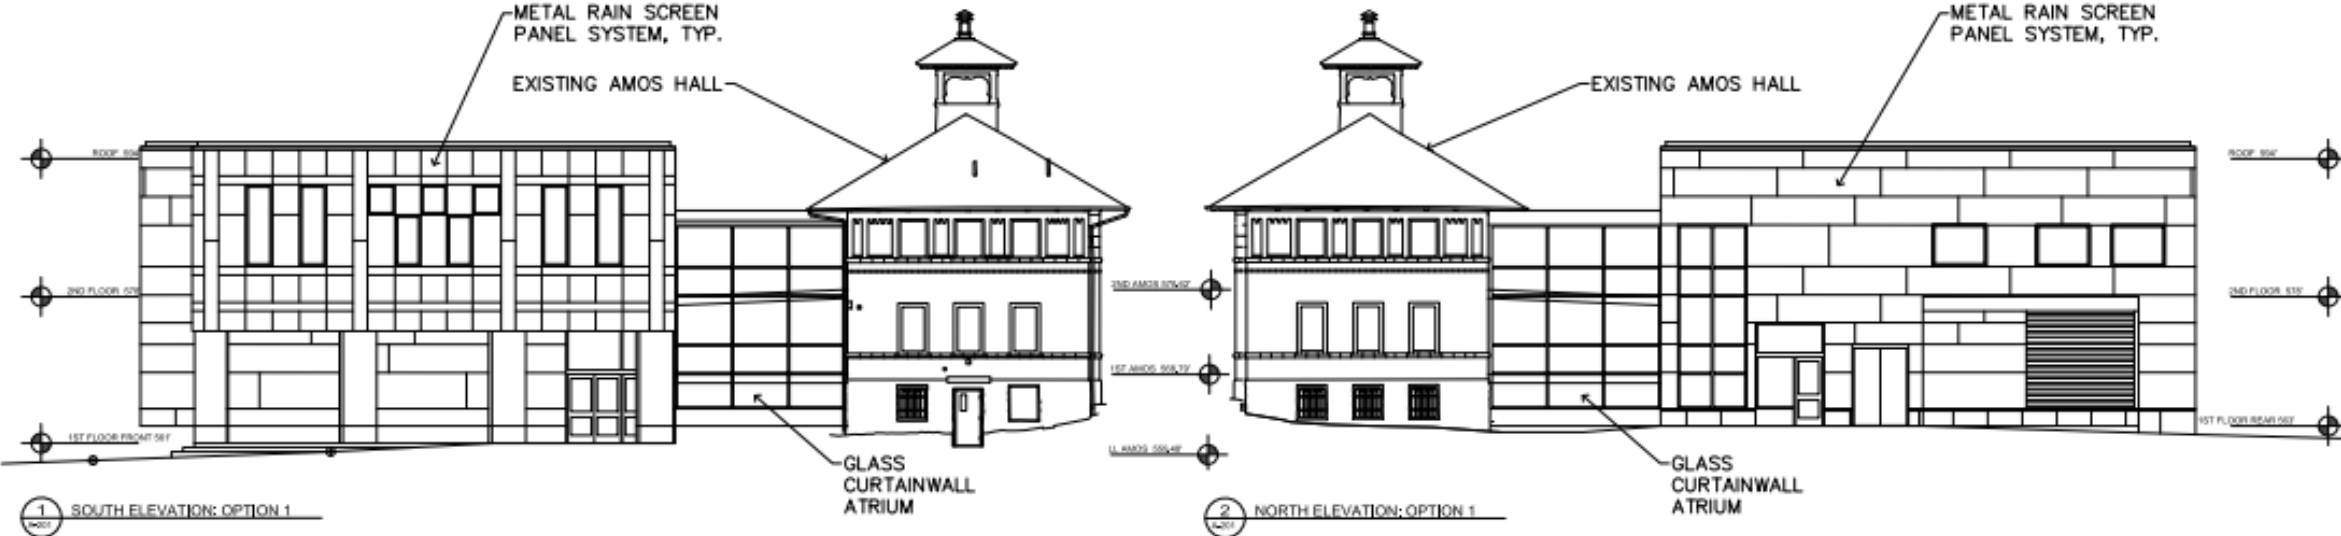
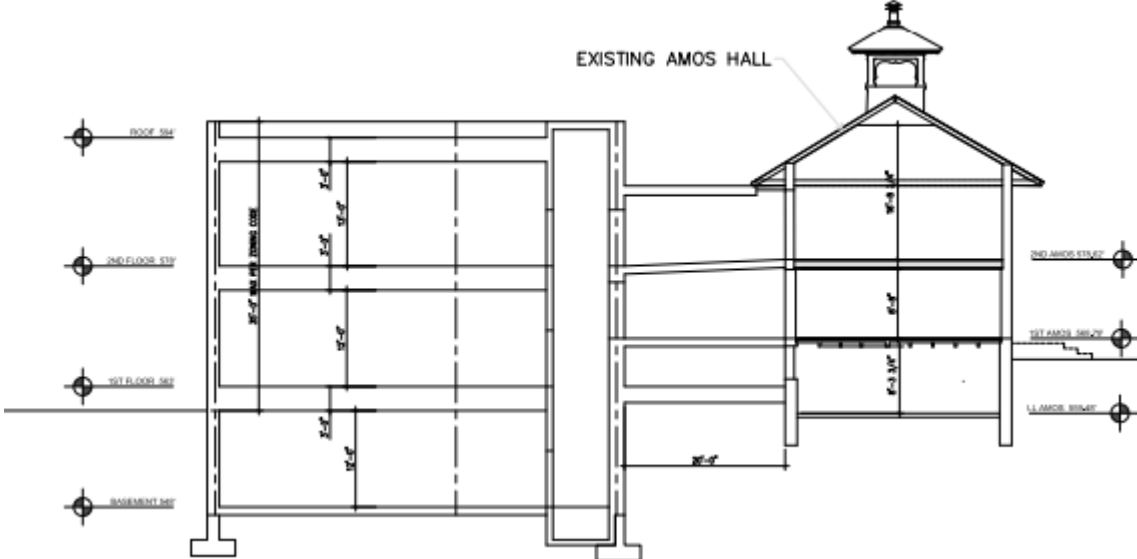
# AMOS HALL – Elevations & Section

A 17,000 sf addition is proposed to the back of Amos.

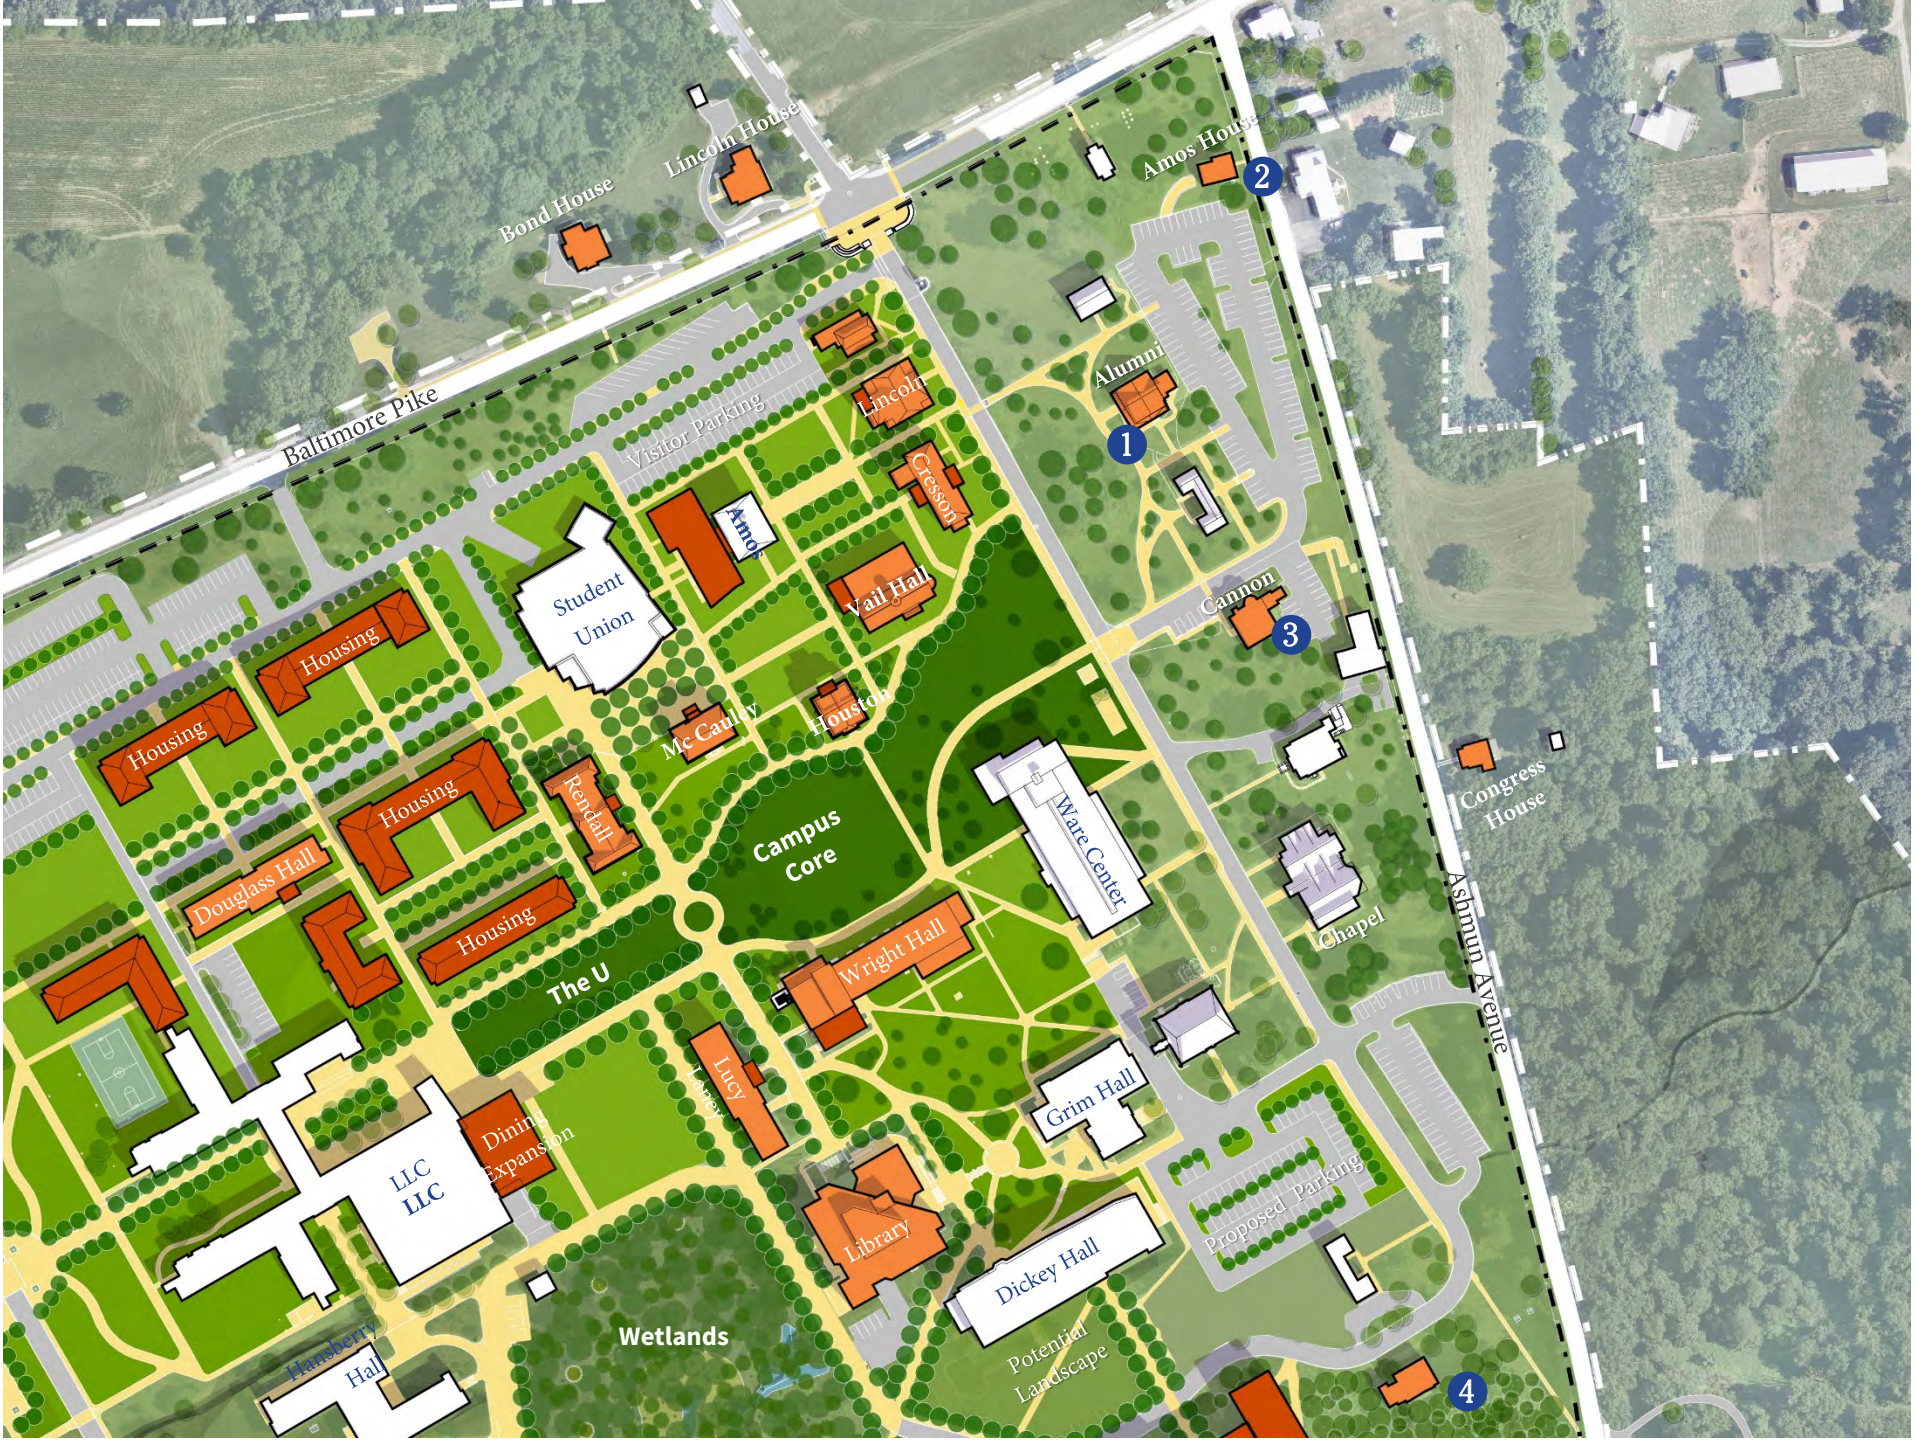
# ON-CAMPUS RESIDENTIAL BUILDINGS

- 1. Alumni House (1870)
- 2. Amos House(c. 1871)
- 3. Cannon House (1874)
- 4. Danjuma African Art Center (1885)
